Access Compliance Report

Public Rights-of-Way

(Curb Ramps)

| Intersection ID: N/A | Main Street: GERALDINE POWE DR | Cross Street: STROUD PARK CT | Location: SE |

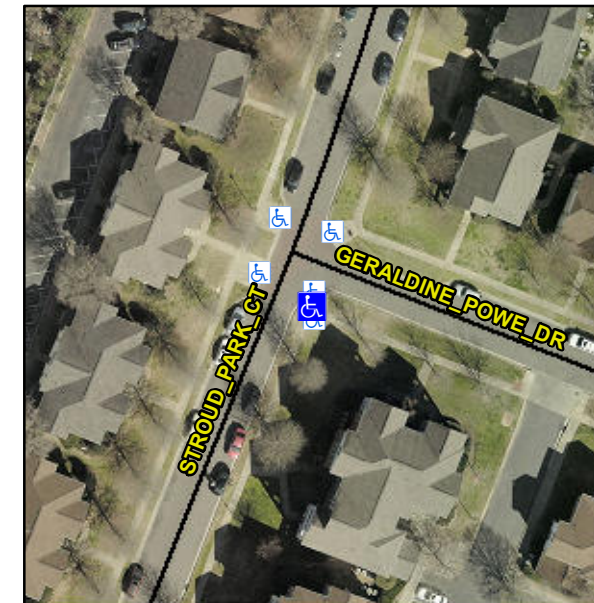
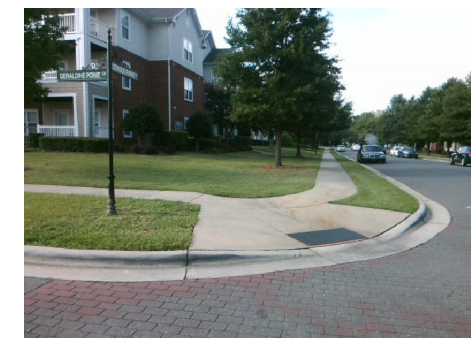
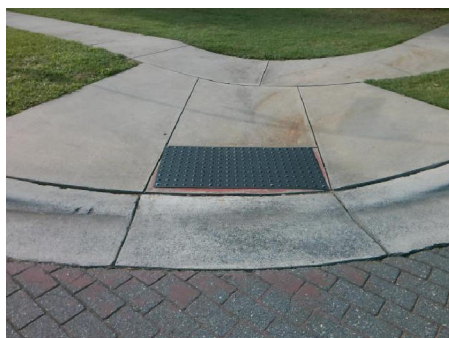
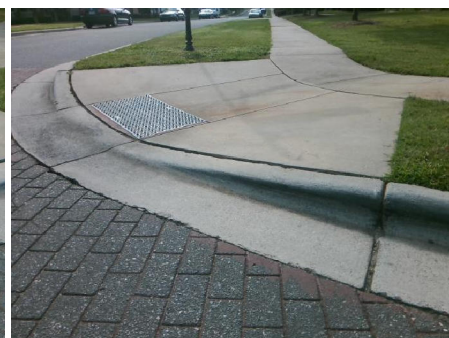
| ADA ID: F2DABF6F939D | Ramp Type: Combination2Diag | Initial Pass/Fail: Fail | Overall Compliance: No |

Not Found, R304.5.1, R304.5.3, R304.3.2

| Compliance | Description | Data | Compliance | Description | Data |
|---|---|---|---|---|---|
| No | Ramp Width LT (in) | 47.5 | Yes | Ramp Width RT (in) | 48.0 |
| No | Ramp Slope LT (%) | 10.6 | Yes | Ramp Slope RT (%) | 4.3 |
| Yes | Ramp Width (in) | 49.0 | No | Ramp XSlope (%) | 4.5 |

Remove & Replace Curb Ramp With Two New Directional Ramps or Equivalent.
