## Access Compliance Report Public Rights-of-Way (Curb Ramps)

Intersection ID: N/AMain Street:S\_CALDWELL\_STCross Street:E\_MARTIN\_LUTHER\_KING\_JR\_BVLocation:NEADA ID: F2E4EEC1954BRamp Type:ParaInitial Pass/Fail:FailOverall Compliance:NoSeverity Score:26.25

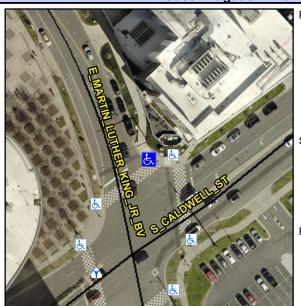
Field Measurements/Component Compilance							
Compliance Description Data		Data	Compliance Description		Data		
N/A	Ramp Length LT (in)	67.0	N/A	Ramp Length RT (in)	56.0		
Yes	Ramp Width LT (in)	94.0	Yes	Ramp Width RT (in)	94.0		
No	Ramp Slope LT (%)	12.0	Yes	Ramp Slope RT (%)	6.0		
No	Ramp XSlope LT (%)	2.1	Yes	Ramp XSlope RT (%)	1.6		
N/A	Landing Length (in)	N/A	N/A	DWS Provided?	N/A		
N/A	Landing Width (in)	N/A	N/A	DWS Contrast?	N/A		
N/A	Landing Slope (%)	N/A	N/A	DWS Length (in)	N/A		
N/A	Landing X Slope (%)	N/A	N/A	DWS Full Width?	N/A		
N/A	Landing Curb? (Y/N)	N/A	N/A	DWS Offset (in)	N/A		
N/A	Shared Landing?	N/A					
N/A	Gutter Ponding?	N/A	N/A	Gutter Slope (%)	N/A		
N/A	Gutter Lip Ht (in)	N/A	N/A	Gutter X Slope (%)	N/A		
N/A	Painted X Walk1?	Yes	N/A	Painted X Walk2?	N/A		
	X Walk 1 Direction	To SW		X Walk 2 Direction	N/A		
N/A	X Walk 1 Width (in)	144.0	N/A	X Walk 2 Width (in)	N/A		
	X Walk 1 Slope (%)	0.7		X Walk 2 Slope (%)	N/A

X Walk 1 X Slope (%)	2.9		X Walk 2 X Slope (%)	N/A		
N/A	Ramp inside XWalk1?	Yes	N/A	Ramp inside XWalk2?	N/A		
	Road Slope (%)	N/A	N/A	Clear Space?	N/A		
	Road X Slope (%)	N/A	N/A	Clear Space to XWalk (in)	N/A		
N/A	Any Obstructions?	N/A	N/A	Storm Grate/Utility Hazard?	N/A		
	Obstruction Type			Storm Grate/Utility Type			
		N/A			N/A		
			Yes	Surface Condition? (G/P)	Good		
			N/A	Curb Slope (%)	4.2

Possible Solutions:	<u>c</u>	
Remove & Replace Entire Ramp.		
•	Y	
	N	
	N	
	N	
	N	
Surveyor Notes:	N	
N/A	N	
	N	
	N	
	N	
PROW/ADA:	N.	
R304.3.2, R304.5.3	N	
	N

Total Cost: \$ 1600.00
