Access Compliance Report

Public Rights-of-Way

(Curb Ramps)

Intersection ID: 3132	Main Street: BASKERVILLE_AV	Cross Street: LENOX_HILL_PL	Location: SW
ADA ID: F2EBFA0B0E31	Ramp Type: Perp	Initial Pass/Fail: Fail	Overall Compliance: No
Severity Score: 1.25			
Codes/Mitigation Info/Possible Solution		Field Measurements/Component Compliance

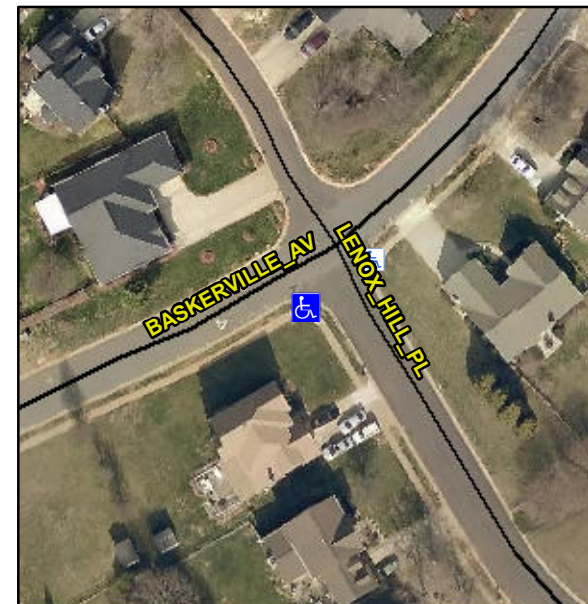
PROW/ADA:

Not Found, R304.5.3

Compliance	Description	Data	Compliance	Description	Data
N/A	Ramp Length (in)	48.0	Yes	Ramp Slope (%)	7.4
Yes	Ramp Width (in)	84.0	No	Ramp XSlope (%)	2.4
N/A	Flare Type LT	N/A	N/A	Flare Type RT	N/A
N/A	Flare Slope LT (%)	N/A	N/A	Flare Slope RT (%)	N/A
N/A	Flare Traversable LT?	N/A	N/A	Flare Traversable RT?	N/A
N/A	Landing Length (in)	N/A	N/A	DWS Provided?	N/A
N/A	Landing Width (in)	N/A	N/A	DWS Contrast?	N/A
N/A	Landing Slope (%)	N/A	N/A	DWS Length (in)	N/A
N/A	Landing X Slope (%)	N/A	N/A	DWS Full Width?	N/A
N/A	Landing Curb? (Y/N)	N/A	N/A	DWS Offset (in)	N/A
N/A	Shared Landing?	N/A			
N/A	Gutter Ponding?	N/A	N/A	Gutter Slope (%)	N/A
N/A	Gutter Lip Ht (in)	N/A	N/A	Gutter X Slope (%)	N/A
N/A	Painted X Walk1?	No	N/A	Painted X Walk2?	N/A
	X Walk 1 Direction	To NE		X Walk 2 Direction	N/A
N/A	X Walk 1 Width (in)	N/A	N/A	X Walk 2 Width (in)	N/A
	X Walk 1 Slope (%)	1.3		X Walk 2 Slope (%)	N/A
	X Walk 1 X Slope (%)	1.4		X Walk 2 X Slope (%)	N/A

N/A	Ramp inside XWalk1?	N/A	N/A	Ramp inside XWalk2?	N/A
	Road Slope (%)	N/A	N/A	Clear Space?	N/A
	Road X Slope (%)	N/A	N/A	Clear Space to XWalk (in)	N/A
N/A	Any Obstructions?	N/A	N/A	Storm Grate/Utility Hazard?	N/A
	Obstruction Type			Storm Grate/Utility Type	
		N/A			N/A
			Yes	Surface Condition? (G/P)	Good

Possible Solutions:

Remove & Replace Entire Ramp.

Total Cost: \$ **1850.00**
