Access Compliance Report

Public Rights-of-Way

(Curb Ramps)

Intersection ID: 50516	Main Street: MICHAEL_CROSSING_DR	Cross Street: MCLEAN_RD	Location: E
ADA ID: F2ED174F157F	Ramp Type: Combination2	Initial Pass/Fail: Fail	Overall Compliance: No
Severity Score: 13.75			
Codes/Mitigation Info/Possible Solution		Field Measurements/Component Compliance

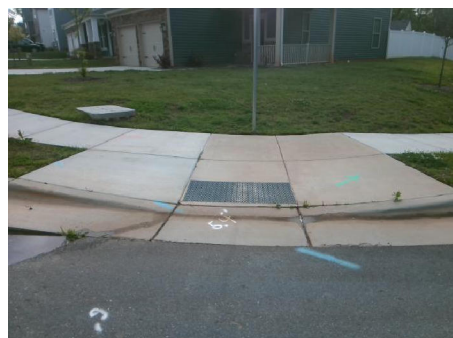
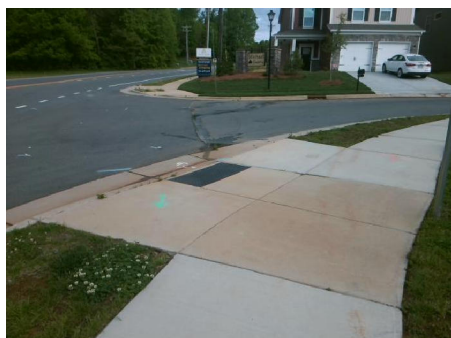
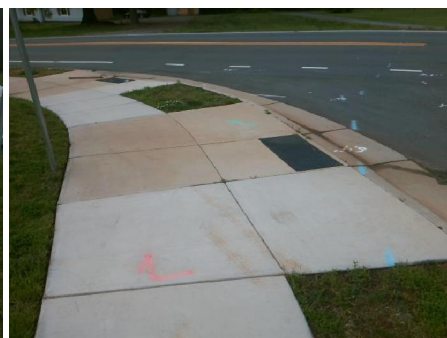
RT RP < 5%

Not Found, R304.5.3, R304.3.2

Compliance	Description	Data	Compliance	Description	Data
N/A	Ramp Length LT (in)	53.0	N/A	Ramp Length RT (in)	47.0
Yes	Ramp Width LT (in)	58.0	N/A	Ramp Width RT (in)	60.0
No	Ramp Slope LT (%)	9.6	N/A	Ramp Slope RT (%)	2.1
Yes	Ramp XSlope LT (%)	1.6	N/A	Ramp XSlope RT (%)	1.1
N/A	Ramp Length (in)	59.5	Yes	Ramp Slope (%)	1.9
Yes	Ramp Width (in)	48.0	No	Ramp XSlope (%)	3.8
N/A	Flare Type LT	N/A	N/A	Flare Type RT	N/A
N/A	Flare Slope LT (%)	N/A	N/A	Flare Slope RT (%)	N/A
N/A	Flare Traversable LT?	N/A	N/A	Flare Traversable RT?	N/A
N/A	Landing Length (in)	N/A	N/A	DWS Provided?	N/A
N/A	Landing Width (in)	N/A	N/A	DWS Contrast?	N/A
N/A	Landing Slope (%)	N/A	N/A	DWS Length (in)	N/A
N/A	Landing X Slope (%)	N/A	N/A	DWS Full Width?	N/A
N/A	Landing Curb? (Y/N)	N/A	N/A	DWS Offset (in)	N/A
N/A	Shared Landing?	N/A			
N/A	Gutter Ponding?	N/A	N/A	Gutter Slope (%)	N/A
N/A	Gutter Lip Ht (in)	N/A	N/A	Gutter X Slope (%)	N/A
N/A	Painted X Walk1?	No	N/A	Painted X Walk2?	N/A

X Walk 1 Direction	To NW		X Walk 2 Direction	N/A
	X Walk 1 Width (in)	N/A		X Walk 2 Width (in)	N/A
	X Walk 1 Slope (%)	2.8		X Walk 2 Slope (%)	N/A
	X Walk 1 X Slope (%)	1.7		X Walk 2 X Slope (%)	N/A
N/A	Ramp inside XWalk1?	N/A	N/A	Ramp inside XWalk2?	N/A
	Road Slope (%)	N/A		Clear Space?	N/A
	Road X Slope (%)	N/A	N/A	Clear Space to XWalk (in)	N/A
			N/A	Any Obstruction?	N/A
				Obstruction Type	N/A
			N/A	Storm Grate/Utility Hazard?	N/A
				Storm Grate/Utility Type	N/A
Yes	Surface Condition? (G/P)	Good			
	Curb Slope (%)	8.1

Possible Solutions:

Remove & Replace Entire Ramp.
