# Access Compliance Report

## Public Rights-of-Way

### (Curb Ramps)

Intersection ID: N/A	Main Street: LANGWELL_LN	Cross Street: HAMILTON_BRIDGE_RD	Location: SW
ADA ID: F2F39EC3D9EF	Ramp Type: Perp	Initial Pass/Fail: Fail	Overall Compliance: No
Codes/Mitigation Info/Possible Solution		Field Measurements/Component Compliance

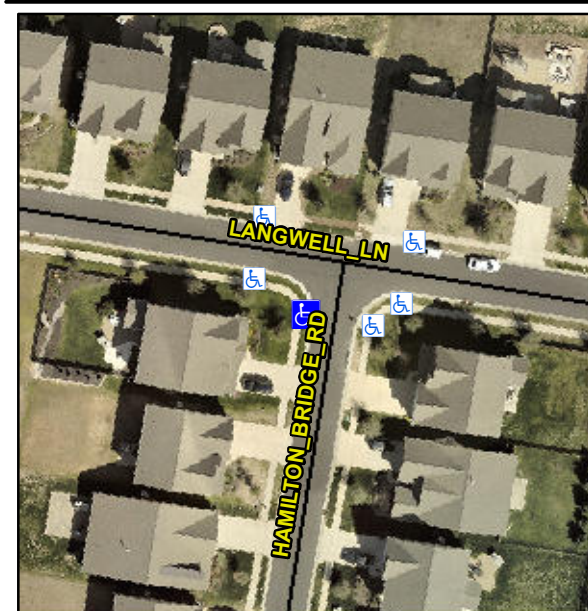
Compliance	Description	Data	Compliance	Description	Data
N/A	Ramp Length (in)	48.0	Yes	Ramp Slope (%)	6.3
No	Ramp Width (in)	47.5	Yes	Ramp XSlope (%)	3.5
N/A	Flare Type LT	N/A	N/A	Flare Type RT	N/A
N/A	Flare Slope LT (%)	N/A	N/A	Flare Slope RT (%)	N/A
N/A	Flare Traversable LT?	N/A	N/A	Flare Traversable RT?	N/A
N/A	Landing Length (in)	N/A	N/A	DWS Provided?	N/A
N/A	Landing Width (in)	N/A	N/A	DWS Contrast?	N/A
N/A	Landing Slope (%)	N/A	N/A	DWS Length (in)	N/A
N/A	Landing X Slope (%)	N/A	N/A	DWS Full Width?	N/A
N/A	Landing Curb? (Y/N)	N/A	N/A	DWS Offset (in)	N/A
N/A	Shared Landing?	N/A			
N/A	Gutter Ponding?	N/A	N/A	Gutter Slope (%)	N/A
N/A	Gutter Lip Ht (in)	N/A	N/A	Gutter X Slope (%)	N/A
N/A	Painted X Walk1?	No	N/A	Painted X Walk2?	N/A
	X Walk 1 Direction	To SE		X Walk 2 Direction	N/A
N/A	X Walk 1 Width (in)	N/A	N/A	X Walk 2 Width (in)	N/A
	X Walk 1 Slope (%)	1.3		X Walk 2 Slope (%)	N/A
	X Walk 1 X Slope (%)	4.1		X Walk 2 X Slope (%)	N/A

N/A	Ramp inside XWalk1?	N/A	N/A	Ramp inside XWalk2?	N/A
	Road Slope (%)	N/A	N/A	Clear Space?	N/A
	Road X Slope (%)	N/A	N/A	Clear Space to XWalk (in)	N/A
N/A	Any Obstructions?	N/A	N/A	Storm Grate/Utility Hazard?	N/A
	Obstruction Type			Storm Grate/Utility Type	
		N/A			N/A
			Yes	Surface Condition? (G/P)	Good

Possible Solutions:

**Remove & Replace Entire Ramp.**

PROW/ADA:

**R304.5.1**
