# Access Compliance Report

## Public Rights-of-Way

### (Curb Ramps)

| Intersection ID: 9579 | Main Street: BANCROFT_ST | Cross Street: FRANKLIN_AV | Location: | S |

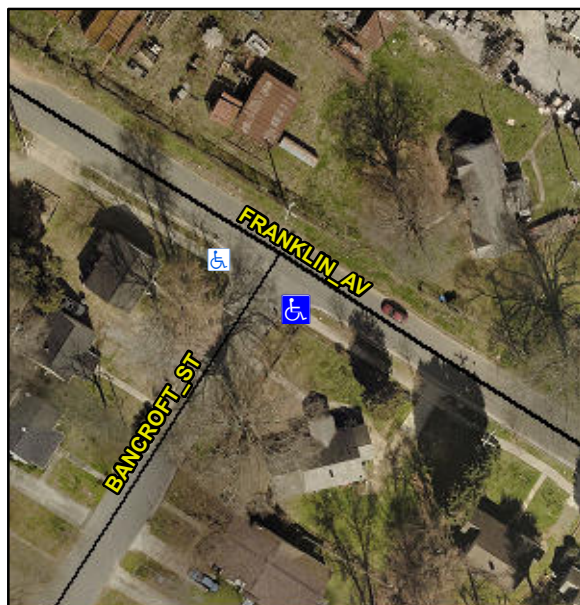
**R304.2.1, R304.5.3, R305.1.4, R305.2, R304.5.4**

| Compliance | Description | Data | Compliance | Description | Data |
|---|---|---|---|---|---|
| Yes | Ramp Width (in) | 59.0 | No | Grade Break Slope (%) | 7.7 |
| No | Landing Length (in) | 44.0 | Yes | DWS Provided? | Yes |
| No | Landing X Slope (%) | 2.1 | No | DWS Full Width? | No |
| Yes | Gutter Ponding? | No | No | Gutter Slope (%) | 5.3 |
| Yes | Gutter Lip Ht (in) | 0.0 | No | Gutter X Slope (%) | 3.0 |

**Remove & Replace Entire Ramp.**  
**Remove & Replace Gutter.**

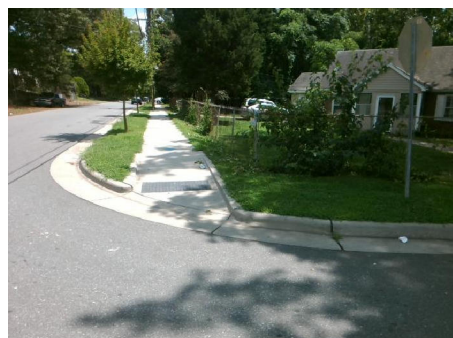
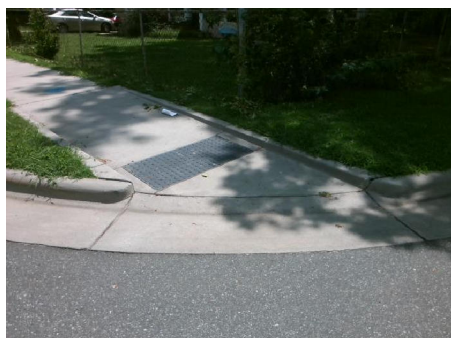
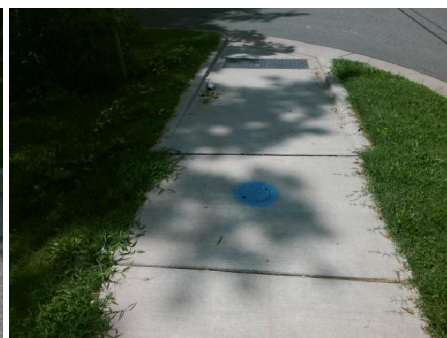
| ADA ID: F3025811C90A | Ramp Type: Directional1 | Initial Pass/Fail: Pass | Overall Compliance: No | Severity Score: 7.5 |
