Access Compliance Report

Public Rights-of-Way

(Curb Ramps)

Intersection ID: 10347	Main Street: KARENDALE_AV	Cross Street: ROGERS_ST	Location: S
ADA ID: F30809C6C35A	Ramp Type: PerpDiag	Initial Pass/Fail: Fail	Overall Compliance: No
Severity Score: 10			
Codes/Mitigation Info/Possible Solution		Field Measurements/Component Compliance

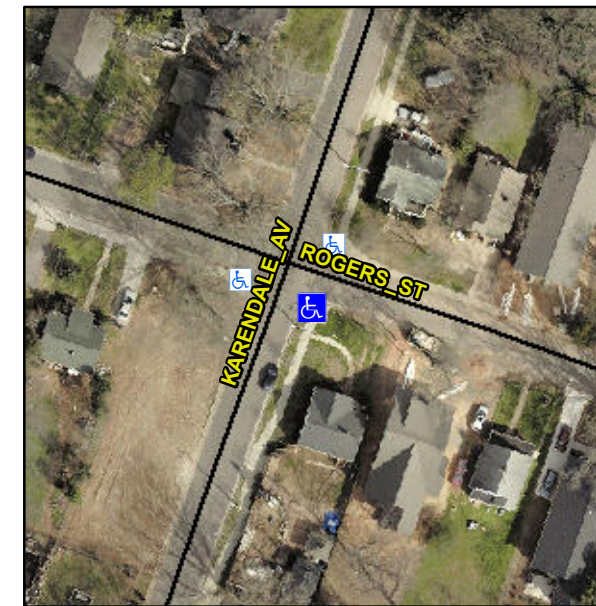
Not Found, R304.5.1, R304.5.3

Compliance	Description	Data	Compliance	Description	Data
N/A	Ramp Length (in)	48.0	Yes	Ramp Slope (%)	7.0
No	Ramp Width (in)	47.5	No	Ramp XSlope (%)	2.3
N/A	Flare Type LT	N/A	N/A	Flare Type RT	N/A
N/A	Flare Slope LT (%)	N/A	N/A	Flare Slope RT (%)	N/A
N/A	Flare Traversable LT?	N/A	N/A	Flare Traversable RT?	N/A
N/A	Landing Length (in)	N/A	N/A	DWS Provided?	N/A
N/A	Landing Width (in)	N/A	N/A	DWS Contrast?	N/A
N/A	Landing Slope (%)	N/A	N/A	DWS Length (in)	N/A
N/A	Landing X Slope (%)	N/A	N/A	DWS Full Width?	N/A
N/A	Landing Curb? (Y/N)	N/A	N/A	DWS Offset (in)	N/A
N/A	Shared Landing?	N/A			
N/A	Gutter Ponding?	N/A	N/A	Gutter Slope (%)	N/A
N/A	Gutter Lip Ht (in)	0.5	N/A	Gutter X Slope (%)	N/A
N/A	Painted X Walk1?	No	N/A	Painted X Walk2?	No
	X Walk 1 Direction	To NE		X Walk 2 Direction	To NW
N/A	X Walk 1 Width (in)	N/A	N/A	X Walk 2 Width (in)	N/A
	X Walk 1 Slope (%)	3.4		X Walk 2 Slope (%)	3.9
	X Walk 1 X Slope (%)	2.2		X Walk 2 X Slope (%)	4.5

N/A	Ramp inside XWalk1?	N/A	N/A	Ramp inside XWalk2?	N/A
	Road Slope (%)	2.5	N/A	Clear Space?	N/A
	Road X Slope (%)	3.7	N/A	Clear Space to XWalk (in)	N/A
N/A	Any Obstructions?	N/A	N/A	Storm Grate/Utility Hazard?	N/A
	Obstruction Type			Storm Grate/Utility Type	
		N/A			N/A
			Yes	Surface Condition? (G/P)	Good

Remove & Replace Curb Ramp With Two New Directional Ramps or Equivalent.
