# Access Compliance Report

## Public Rights-of-Way

### (Curb Ramps)

| Intersection ID: 50476 | Main Street: BOW_RD | Cross Street: KINGS_RIDGE_DR | Location: S |

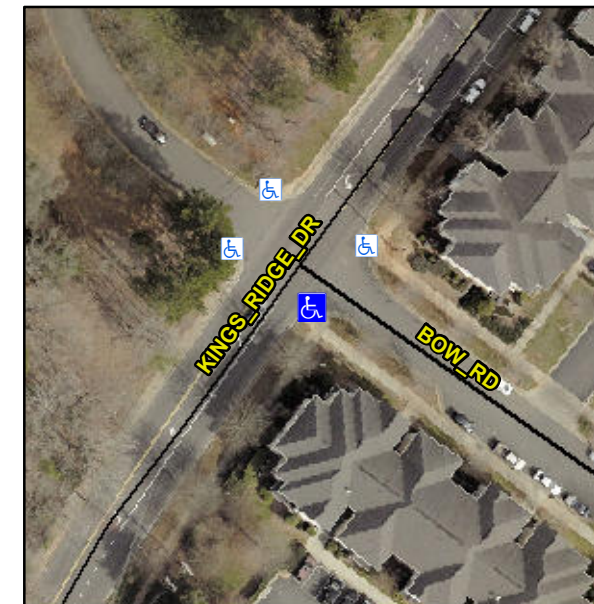
**Not Found, R304.5.1, R304.2.2, R304.5.3**

| Compliance | Description | Data | Compliance | Description | Data |
|---|---|---|---|---|---|
| N/A | Ramp Length (in) | 77.5 | No | Ramp Slope (%) | 8.7 |
| No | Ramp Width (in) | 47.0 | No | Ramp XSlope (%) | 2.6 |

**Remove & Replace Curb Ramp With Two New Directional Ramps or Equivalent.**

Total Cost: \$ 3200.00

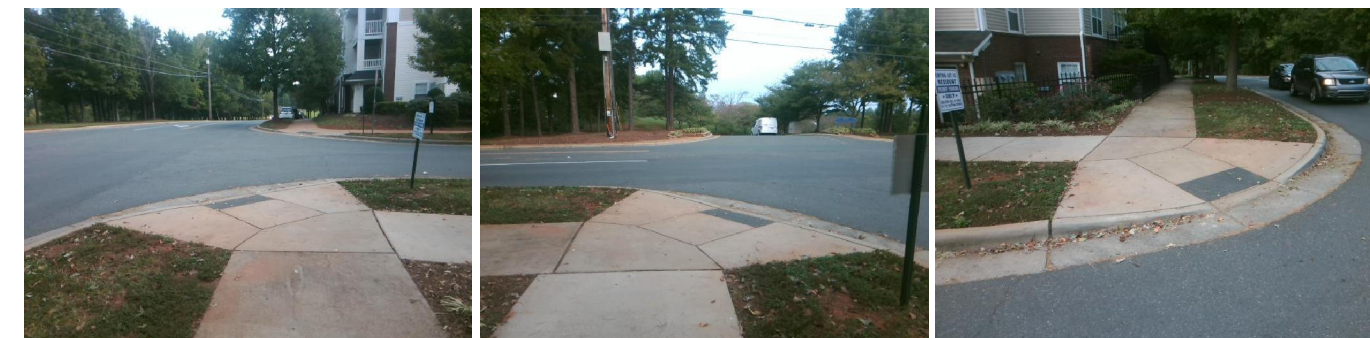
Street 1 Name BOW RD  
 Stop Condition-Street 2 StopSign  
 Street 2 Name KINGS RIDGE DR  
 Stop Condition-Street 1 None
