Access Compliance Report

Public Rights-of-Way

(Curb Ramps)

Intersection ID: 26371	Main Street: BEVINGTON_PL	Cross Street: HEMINGFORD_CT	Location: NE
ADA ID: F30E44EF7249	Ramp Type: BlendTrans2	Initial Pass/Fail: Fail	Overall Compliance: No
		Severity Score: 25

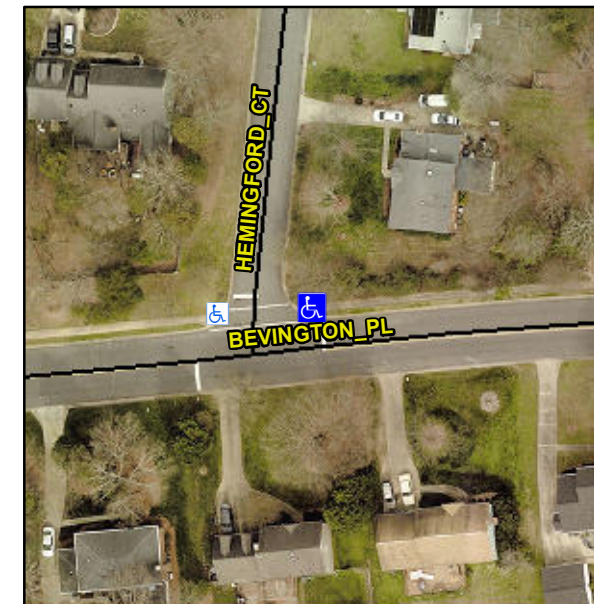
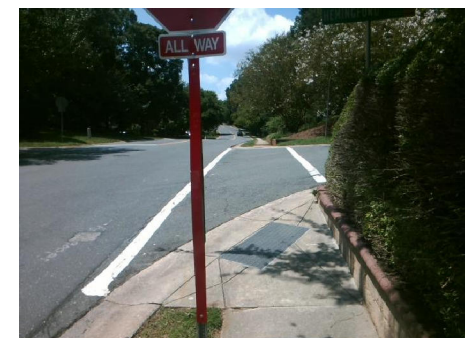
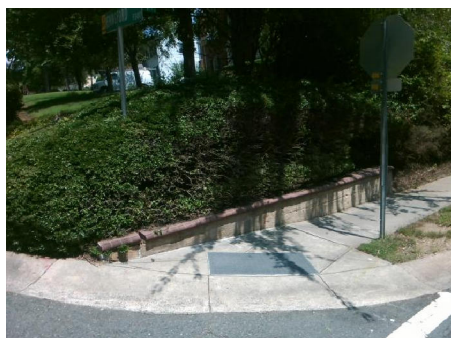
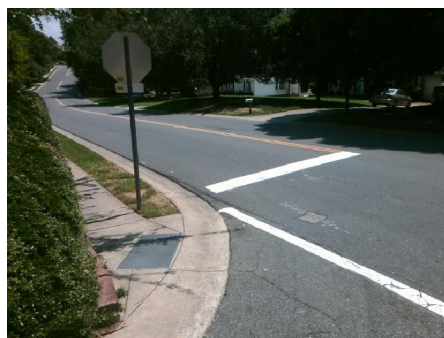
Not Found, R304.5.3

Compliance	Description	Data	Compliance	Description	Data
N/A	Ramp Length (in)	38.0	Yes	BlendTrans Slope (%)	1.2
Yes	Ramp Width (in)	48.0	No	BlendTrans XSlope (%)	15.0
N/A	Flare Type LT	N/A	N/A	Flare Type RT	N/A
N/A	Flare Slope LT (%)	N/A	N/A	Flare Slope RT (%)	N/A
N/A	Flare Traversable LT?	N/A	N/A	Flare Traversable RT?	N/A
N/A	Landing Length (in)	N/A	N/A	DWS Provided?	N/A
N/A	Landing Width (in)	N/A	N/A	DWS Contrast?	N/A
N/A	Landing Slope (%)	N/A	N/A	DWS Length (in)	N/A
N/A	Landing X Slope (%)	N/A	N/A	DWS Full Width?	N/A
N/A	Landing Curb? (Y/N)	N/A	N/A	DWS Offset (in)	N/A
N/A	Shared Landing?	N/A			
N/A	Gutter Ponding?	N/A	N/A	Gutter Slope (%)	N/A
N/A	Gutter Lip Ht (in)	N/A	N/A	Gutter X Slope (%)	N/A
N/A	Painted X Walk1?	Yes	N/A	Painted X Walk2?	No
	X Walk 1 Direction	To W		X Walk 2 Direction	To S
	X Walk 1 Width (in)	108.0		X Walk 2 Width (in)	N/A
	X Walk 1 Slope (%)	4.5		X Walk 2 Slope (%)	2.2
	X Walk 1 X Slope (%)	13.1		X Walk 2 X Slope (%)	6.0

N/A	Ramp inside XWalk1?	Yes	N/A	Ramp inside XWalk2?	N/A
	Road Slope (%)	12.1		Clear Space?	N/A
	Road X Slope (%)	4.2	N/A	Clear Space to XWalk (in)	N/A
N/A	Any Obstructions?	N/A	N/A	Storm Grate/Utility Hazard?	N/A
	Obstruction Type			Storm Grate/Utility Type	
		N/A			N/A
		Yes		Surface Condition? (G/P)	Good
		No		Curb Slope (%)	6.0

Remove & Replace Curb Ramp With Two New Directional Ramps or Equivalent.
