# Access Compliance Report

## Public Rights-of-Way

### (Curb Ramps)

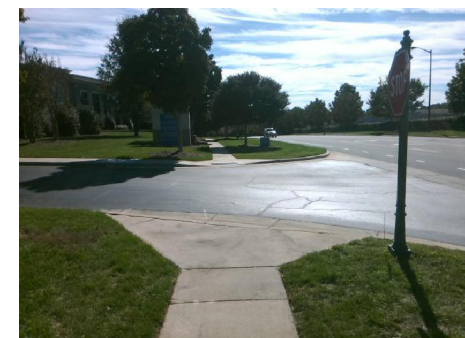
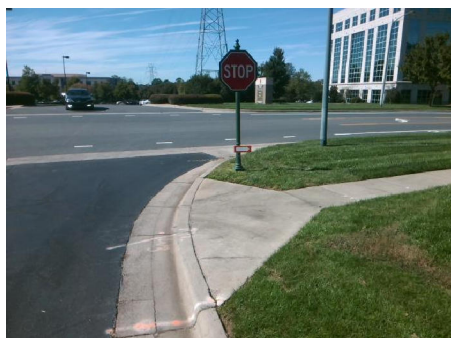
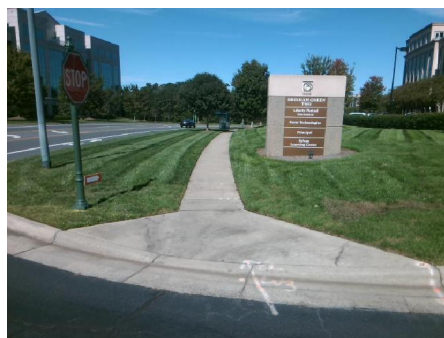
Intersection ID: 10020376	Main Street: BALLANTYNE CORPORATE PL	Cross Street: N/A	Location: NE
ADA ID: F32E843FAFCB	Ramp Type: BlendTrans2	Initial Pass/Fail: Fail	Overall Compliance: No
Severity Score: 12.5			
Codes/Mitigation Info/Possible Solution		Field Measurements/Component Compliance

Compliance	Description	Data	Compliance	Description	Data
N/A	Ramp Length (in)	77.0	Yes	BlendTrans Slope (%)	2.5
Yes	Ramp Width (in)	48.0	No	BlendTrans XSlope (%)	5.5
N/A	Flare Type LT	N/A	N/A	Flare Type RT	N/A
N/A	Flare Slope LT (%)	N/A	N/A	Flare Slope RT (%)	N/A
N/A	Flare Traversable LT?	N/A	N/A	Flare Traversable RT?	N/A
N/A	Landing Length (in)	N/A	N/A	DWS Provided?	N/A
N/A	Landing Width (in)	N/A	N/A	DWS Contrast?	N/A
N/A	Landing Slope (%)	N/A	N/A	DWS Length (in)	N/A
N/A	Landing X Slope (%)	N/A	N/A	DWS Full Width?	N/A
N/A	Landing Curb? (Y/N)	N/A	N/A	DWS Offset (in)	N/A
N/A	Shared Landing?	N/A			
N/A	Gutter Ponding?	N/A	N/A	Gutter Slope (%)	N/A
N/A	Gutter Lip Ht (in)	N/A	N/A	Gutter X Slope (%)	N/A
N/A	Painted X Walk1?	No	N/A	Painted X Walk2?	N/A
	X Walk 1 Direction	To S		X Walk 2 Direction	N/A
	X Walk 1 Width (in)	N/A		X Walk 2 Width (in)	N/A
	X Walk 1 Slope (%)	2.6		X Walk 2 Slope (%)	N/A
	X Walk 1 X Slope (%)	3.1		X Walk 2 X Slope (%)	N/A

N/A	Ramp inside XWalk1?	N/A	N/A	Ramp inside XWalk2?	N/A
	Road Slope (%)	3.1		Clear Space?	N/A
	Road X Slope (%)	2.6	N/A	Clear Space to XWalk (in)	N/A
N/A	Any Obstructions?	N/A	N/A	Storm Grate/Utility Hazard?	N/A
	Obstruction Type			Storm Grate/Utility Type	
		N/A			N/A
			Yes	Surface Condition? (G/P)	Good
			N/A	Curb Slope (%)	0.0

**Remove & Replace Curb Ramp With Two New Directional Ramps or Equivalent.**
