Access Compliance Report Public Rights-of-Way (Curb Ramps)

Intersection ID: 3448 Main Street: W_W_T_HARRIS_BV_TO_I-77_RAOSBStreet: I-77_TO_W_W_T_HARRIS_BV_RA_SB Location: NE

ADA ID: F32F06A72587 Ramp Type: Para Initial Pass/Fail: Fail Overall Compliance: No Severity Score: 13.75

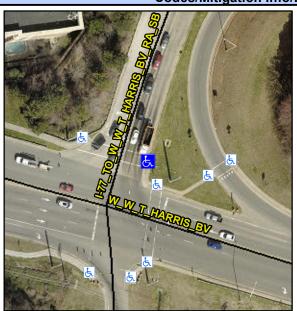
N/
Ye
Ye
Ye
N/
Surveyor Notes:

LT RP < 5%

N/
N/
PROW/ADA:
R304.3.2, R304.5.3

Compliance Description Da		Data	Compliance Description		Data
N/A	Ramp Length LT (in)	60.0	N/A	Ramp Length RT (in)	60.0
Yes	Ramp Width LT (in)	60.0	Yes	Ramp Width RT (in)	60.0
Yes	Ramp Slope LT (%)	3.4	No	Ramp Slope RT (%)	9.1
Yes	Ramp XSlope LT (%)	2.0	No	Ramp XSlope RT (%)	2.5
N/A	Landing Length (in)	N/A	N/A	DWS Provided?	N/A
N/A	Landing Width (in)	N/A	N/A	DWS Contrast?	N/A
N/A	Landing Slope (%)	N/A	N/A	DWS Length (in)	N/A
N/A	Landing X Slope (%)	N/A	N/A	DWS Full Width?	N/A
N/A	Landing Curb? (Y/N)	N/A	N/A	DWS Offset (in)	N/A
N/A	Shared Landing?	N/A			
N/A	Gutter Ponding?	N/A	N/A	Gutter Slope (%)	N/A
N/A	Gutter Lip Ht (in)	N/A	N/A	Gutter X Slope (%)	N/A
N/A	Painted X Walk1?	Yes	N/A	Painted X Walk2?	N/A
	X Walk 1 Direction	To NW		X Walk 2 Direction	N/A
N/A	X Walk 1 Width (in)	136.0	N/A	X Walk 2 Width (in)	N/A
	X Walk 1 Slope (%)	1.7		X Walk 2 Slope (%)	N/A
	X Walk 1 X Slope (%)	1.2		X Walk 2 X Slope (%)	N/A

N/A	Ramp inside XWalk1?	Yes	N/A	Ramp inside XWalk2?	N/A
	Road Slope (%)	N/A	N/A	Clear Space?	N/A
	Road X Slope (%)	N/A	N/A	Clear Space to XWalk (in)	N/A
N/A	Any Obstructions?	N/A	N/A	Storm Grate/Utility Hazard?	N/A
	Obstruction Type			Storm Grate/Utility Type	
		N/A			N/A
			Yes	Surface Condition? (G/P)	Good
			N/A	Curb Slope (%)	4.4
TOLL.	the sealing .				
TO STATE OF THE	The state of the s

Possible Solutions:

Remove & Replace Entire Ramp.

Total Cost: \$ 1600.00
