# Access Compliance Report

## Public Rights-of-Way

### (Curb Ramps)

| Intersection ID: 15001 | Main Street: N_DOTGER_AV | Cross Street: VAIL_AV | Location: | E |

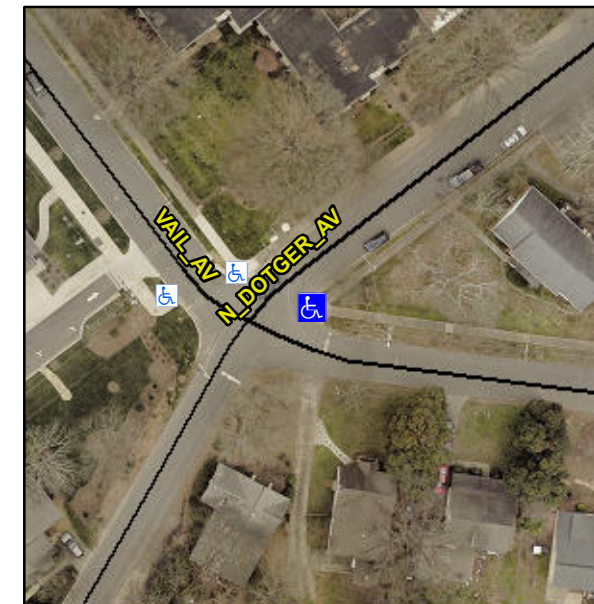
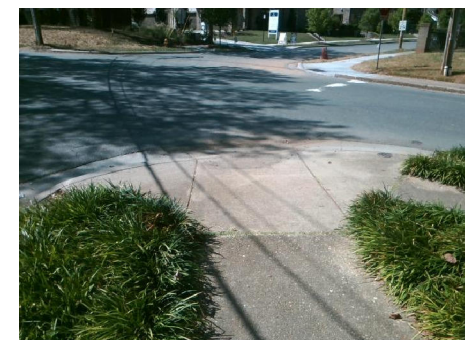
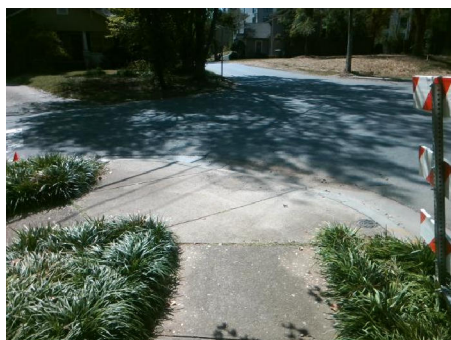
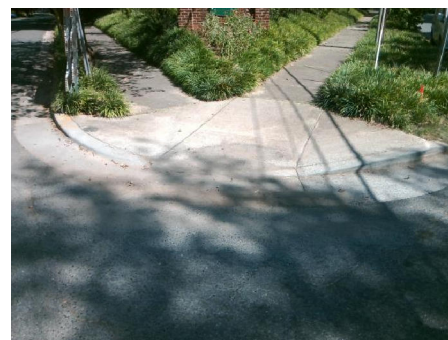
| ADA ID: F3313E83FE11 | Ramp Type: BlendTrans1 | Initial Pass/Fail: Fail | Overall Compliance: No | Severity Score: 1.25 |

| Compliance | Description | Data | Compliance | Description | Data |
|---|---|---|---|---|---|
| N/A | Ramp Length (in) | 87.0 | Yes | BlendTrans Slope (%) | 4.3 |
| Yes | Ramp Width (in) | 59.0 | No | BlendTrans XSlope (%) | 2.8 |
| | | | Yes | Surface Condition? (G/P) | Good |

**Remove & Replace Curb Ramp With Two New Directional Ramps or Equivalent.**

**R304.5.3**

**\$ 3200.00**
