Access Compliance Report

Public Rights-of-Way

(Curb Ramps)

Intersection ID: 53162	Main Street: OBAN_CT	Cross Street: HAMILTON_BRIDGE_RD	Location: SW
ADA ID: F3442A599C71	Ramp Type: BlendTrans1	Initial Pass/Fail: Fail	Overall Compliance: No
		Severity Score: 8.75

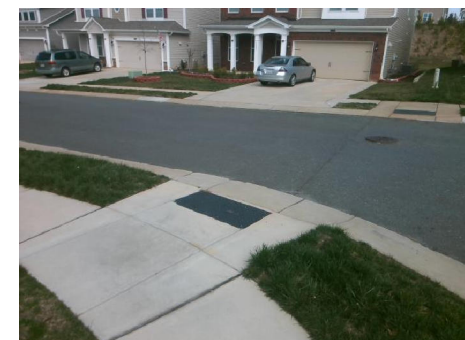
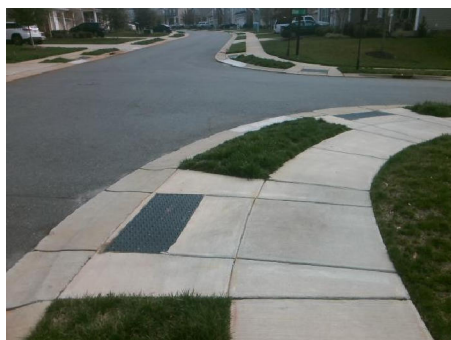
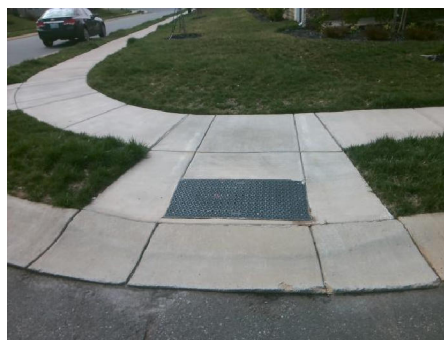
Compliance	Description	Data	Compliance	Description	Data
N/A	Ramp Length (in)	49.5	Yes	BlendTrans Slope (%)	3.0
No	Ramp Width (in)	45.0	Yes	BlendTrans XSlope (%)	1.2
N/A	Flare Type LT	N/A	N/A	Flare Type RT	N/A
N/A	Flare Slope LT (%)	N/A	N/A	Flare Slope RT (%)	N/A
N/A	Flare Traversable LT?	N/A	N/A	Flare Traversable RT?	N/A
N/A	Landing Length (in)	N/A	N/A	DWS Provided?	N/A
N/A	Landing Width (in)	N/A	N/A	DWS Contrast?	N/A
N/A	Landing Slope (%)	N/A	N/A	DWS Length (in)	N/A
N/A	Landing X Slope (%)	N/A	N/A	DWS Full Width?	N/A
N/A	Landing Curb? (Y/N)	N/A	N/A	DWS Offset (in)	N/A
N/A	Shared Landing?	N/A			
N/A	Gutter Ponding?	N/A	N/A	Gutter Slope (%)	N/A
N/A	Gutter Lip Ht (in)	1.0	N/A	Gutter X Slope (%)	N/A
N/A	Painted X Walk1?	No	N/A	Painted X Walk2?	N/A
	X Walk 1 Direction	To NE		X Walk 2 Direction	N/A
	X Walk 1 Width (in)	N/A		X Walk 2 Width (in)	N/A
	X Walk 1 Slope (%)	4.7		X Walk 2 Slope (%)	N/A
	X Walk 1 X Slope (%)	3.4		X Walk 2 X Slope (%)	N/A

N/A	Ramp inside XWalk1?	N/A	N/A	Ramp inside XWalk2?	N/A
	Road Slope (%)	3.4		Clear Space?	N/A
	Road X Slope (%)	4.7	N/A	Clear Space to XWalk (in)	N/A
N/A	Any Obstructions?	N/A	N/A	Storm Grate/Utility Hazard?	N/A
	Obstruction Type			Storm Grate/Utility Type	
		N/A			N/A
			Yes	Surface Condition? (G/P)	Good
			N/A	Curb Slope (%)	2.9

Remove & Replace Curb Ramp With Two New Directional Ramps or Equivalent.
