Access Compliance Report

Public Rights-of-Way

(Curb Ramps)

Intersection ID: 11200	Main Street: MILTON_RD	Cross Street: VILLAGE_GREEN_DR	Location: SW
ADA ID: F34F8CD7AB25	Ramp Type: Perp	Initial Pass/Fail: Fail	Overall Compliance: No
Severity Score: 31.25			
Codes/Mitigation Info/Possible Solution		Field Measurements/Component Compliance

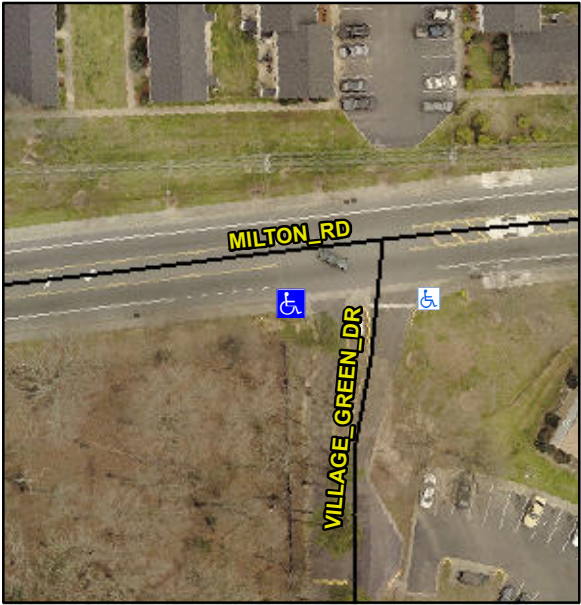
Possible Solutions:				
	Remove & Replace Entire Ramp.				
	Surveyor Notes:				
	N/A				
	PROW/ADA:				
	Not Found, R304.5.1, R304.2.2, R304.5.3				
	Street 1 Name	VILLAGE GREEN DR			
	Stop Condition-Street 2	StopSign			
	Street 2 Name	N/A			
	Stop Condition-Street 1	N/A			
Total Cost:		\$	1850.00		
		Compliance	Description	Data	Compliance Description Data
		N/A	Ramp Length (in)	59.5	No Ramp Slope (%) 11.2
		No	Ramp Width (in)	34.0	No Ramp XSlope (%) 2.7
		N/A	Flare Type LT	N/A	N/A Flare Type RT N/A
		N/A	Flare Slope LT (%)	N/A	N/A Flare Slope RT (%) N/A
		N/A	Flare Traversable LT?	N/A	N/A Flare Traversable RT? N/A
		N/A	Landing Length (in)	N/A	N/A DWS Provided? N/A
		N/A	Landing Width (in)	N/A	N/A DWS Contrast? N/A
		N/A	Landing Slope (%)	N/A	N/A DWS Length (in) N/A
		N/A	Landing X Slope (%)	N/A	N/A DWS Full Width? N/A
		N/A	Landing Curb? (Y/N)	N/A	N/A DWS Offset (in) N/A
		N/A	Shared Landing?	N/A	
		N/A	Gutter Ponding?	N/A	N/A Gutter Slope (%) N/A

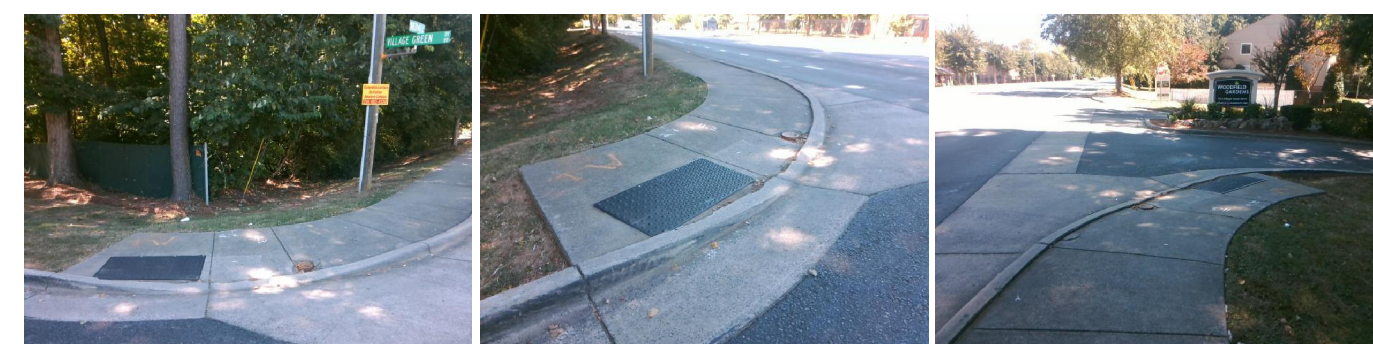
N/A	Gutter Lip Ht (in)	N/A	N/A Gutter X Slope (%) N/A
		N/A	Painted X Walk1?	No	N/A Painted X Walk2? N/A
			X Walk 1 Direction	To E	X Walk 2 Direction N/A
		N/A	X Walk 1 Width (in)	N/A	N/A X Walk 2 Width (in) N/A
			X Walk 1 Slope (%)	1.1	X Walk 2 Slope (%) N/A
			X Walk 1 X Slope (%)	8.0	X Walk 2 X Slope (%) N/A
		N/A	Ramp inside XWalk1?	N/A	N/A Ramp inside XWalk2? N/A
			Road Slope (%)	N/A	N/A Clear Space? N/A
			Road X Slope (%)	N/A	N/A Clear Space to XWalk (in) N/A
		N/A	Any Obstructions?	N/A	N/A Storm Grate/Utility Hazard? N/A
			Obstruction Type		Storm Grate/Utility Type
				N/A	N/A
				Yes	Surface Condition? (G/P) Good
