Access Compliance Report

Public Rights-of-Way

(Curb Ramps)

Intersection ID: 23715	Main Street: BRANDON_FOREST_DR	Cross Street: VON_THURINGER_CT	Location: SW
ADA ID: F3575C47AA22	Ramp Type: PerpDiag	Initial Pass/Fail: Fail	Overall Compliance: No
Severity Score: 33.75			
Codes/Mitigation Info/Possible Solution		Field Measurements/Component Compliance

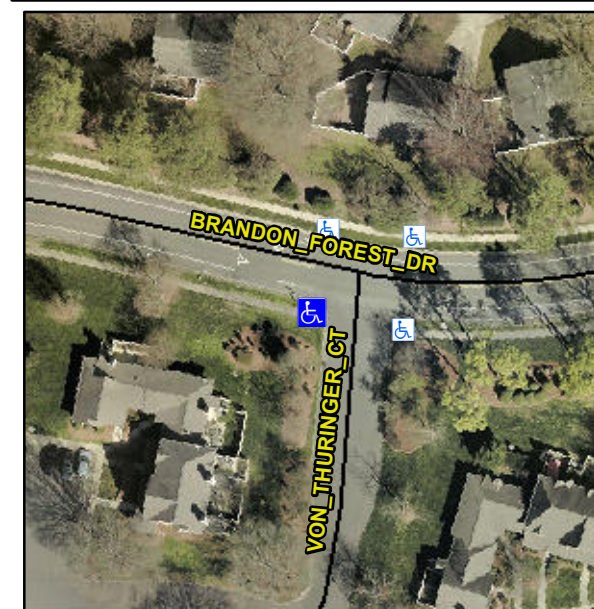
Not Found, R304.5.1, R304.5.3

Compliance	Description	Data	Compliance	Description	Data
N/A	Ramp Length (in)	52.0	Yes	Ramp Slope (%)	7.4
No	Ramp Width (in)	38.0	No	Ramp XSlope (%)	8.6
N/A	Flare Type LT	N/A	N/A	Flare Type RT	N/A
N/A	Flare Slope LT (%)	N/A	N/A	Flare Slope RT (%)	N/A
N/A	Flare Traversable LT?	N/A	N/A	Flare Traversable RT?	N/A
N/A	Landing Length (in)	N/A	N/A	DWS Provided?	N/A
N/A	Landing Width (in)	N/A	N/A	DWS Contrast?	N/A
N/A	Landing Slope (%)	N/A	N/A	DWS Length (in)	N/A
N/A	Landing X Slope (%)	N/A	N/A	DWS Full Width?	N/A
N/A	Landing Curb? (Y/N)	N/A	N/A	DWS Offset (in)	N/A
N/A	Shared Landing?	N/A			
N/A	Gutter Ponding?	N/A	N/A	Gutter Slope (%)	N/A
N/A	Gutter Lip Ht (in)	N/A	N/A	Gutter X Slope (%)	N/A
N/A	Painted X Walk1?	No	N/A	Painted X Walk2?	No
	X Walk 1 Direction	To SE		X Walk 2 Direction	To N
N/A	X Walk 1 Width (in)	N/A	N/A	X Walk 2 Width (in)	N/A
	X Walk 1 Slope (%)	0.4		X Walk 2 Slope (%)	4.3
	X Walk 1 X Slope (%)	0.8		X Walk 2 X Slope (%)	1.8

N/A	Ramp inside XWalk1?	N/A	N/A	Ramp inside XWalk2?	N/A
	Road Slope (%)	2.8	N/A	Clear Space?	N/A
	Road X Slope (%)	1.0	N/A	Clear Space to XWalk (in)	N/A
N/A	Any Obstructions?	N/A	N/A	Storm Grate/Utility Hazard?	N/A
	Obstruction Type			Storm Grate/Utility Type	
		N/A			N/A
		Yes		Surface Condition? (G/P)	Good

Remove & Replace Curb Ramp With Two New Directional Ramps or Equivalent.
