# Access Compliance Report

## Public Rights-of-Way

### (Curb Ramps)

Intersection ID: 10853	Main Street: BARRINGTON_DR	Cross Street: DELIVAU_DR	Location: NW
ADA ID: F36A8FE407F7	Ramp Type: Combination1	Initial Pass/Fail: Fail	Overall Compliance: No
			Severity Score: 21.25

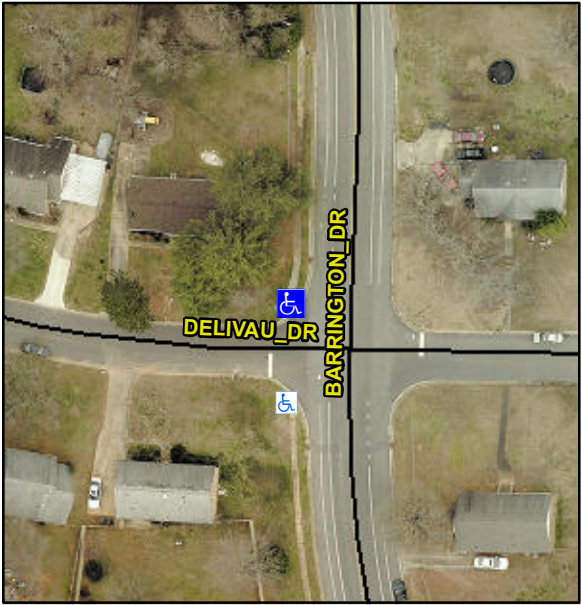
Possible Solutions:		<b>Compliance</b>	<b>Description</b>	<b>Data</b>
	<b>Remove &amp; Replace Entire Ramp.</b>		<b>N/A</b>	Ramp Length LT (in)	<b>45.0</b>
			<b>No</b>	Ramp Width LT (in)	<b>47.5</b>
			<b>Yes</b>	Ramp Slope LT (%)	<b>6.7</b>
			<b>No</b>	Ramp XSlope LT (%)	<b>3.5</b>
			<b>N/A</b>	Ramp Length (in)	<b>48.0</b>
			<b>No</b>	Ramp Width (in)	<b>47.0</b>
	Surveyor Notes:		<b>N/A</b>	Flare Type LT	<b>N/A</b>
	<b>N/A</b>		<b>N/A</b>	Flare Slope LT (%)	<b>N/A</b>
			<b>N/A</b>	Flare Traversable LT?	<b>N/A</b>
<p>PROW/ADA:</p> <p><b>Not Found, R304.5.1, R304.5.1, R304.5.3</b></p>			<b>N/A</b>	Landing Length (in)	<b>N/A</b>
			<b>N/A</b>	Landing Width (in)	<b>N/A</b>
			<b>N/A</b>	Landing Slope (%)	<b>N/A</b>
			<b>N/A</b>	Landing X Slope (%)	<b>N/A</b>
			<b>N/A</b>	Landing Curb? (Y/N)	<b>N/A</b>
			<b>N/A</b>	Shared Landing?	<b>N/A</b>

<b>N/A</b>	Gutter Ponding?	<b>N/A</b>
			<b>N/A</b>	Gutter Lip Ht (in)	<b>N/A</b>
			<b>N/A</b>	Painted X Walk1?	<b>No</b>
				X Walk 1 Direction	<b>To S</b>
<p>Total Cost:</p> <p><b>\$ 1800.00</b></p>			<b>N/A</b>	X Walk 1 Width (in)	<b>N/A</b>
				X Walk 1 Slope (%)	<b>6.3</b>
				X Walk 1 X Slope (%)	<b>0.5</b>
			<b>N/A</b>	Ramp inside XWalk1?	<b>N/A</b>
				Road Slope (%)	<b>N/A</b>
				Road X Slope (%)	<b>N/A</b>
			<b>N/A</b>	Clear Space?	<b>N/A</b>
			<b>N/A</b>	Clear Space to XWalk (in)	<b>N/A</b>
			<b>N/A</b>	Any Obstruction?	<b>N/A</b>
				Obstruction Type	<b>N/A</b>

Storm Grate/Utility Hazard?	<b>N/A</b>
				Storm Grate/Utility Type	<b>N/A</b>
					<b>N/A</b>
			<b>Yes</b>	Surface Condition? (G/P)	<b>Good</b>
				Curb Slope (%)	<b>27.6</b>
