## **Access Compliance Report Public Rights-of-Way** (Curb Ramps)

Intersection ID: 14690 Main Street: LINGANORE PL **Cross Street: ROMANY RD** Location: NE **Overall Compliance: No** ADA ID: F3789A570ED0 Ramp Type: PerpDiag Initial Pass/Fail: Fail **Severity Score:** 12.5

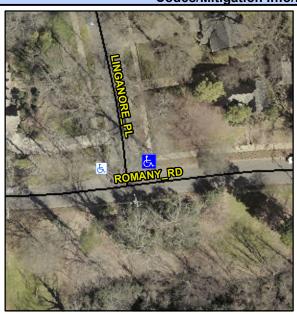
43.0 No

70.0 Yes

Ramp Length (in)

Ramp Width (in)

Ramp Slope (%)

Ramp XSlope (%)

Possible Solutions: Compliance Description **Remove & Replace Curb Ramp With** N/A Two New Directional Ramps or Yes

Equivalent.			N/A	Flare Type LT	N/A	N/A	Flare Type RT	N/A
2	44				N/A	Flare Slope LT (%)	N/A	N/A	Flare Slope RT (%)	N/A
	444				N/A	Flare Traversable LT?	N/A	N/A	Flare Traversable RT?	N/A
	The second second				N/A	Landing Length (in)	N/A	N/A	DWS Provided?	N/A
NAME OF THE PARTY		Surveyor Notes:			N/A	Landing Width (in)	N/A	N/A	DWS Contrast?	N/A
ू <mark>है</mark>		N/A			N/A	Landing Slope (%)	N/A	N/A	DWS Length (in)	N/A
ROMANY	RD .				N/A	Landing X Slope (%)	N/A	N/A	DWS Full Width?	N/A
The Bullion of					N/A	Landing Curb? (Y/N)	N/A	N/A	DWS Offset (in)	N/A
	PART WAR				N/A	Shared Landing?	N/A			
A STATE OF THE PARTY OF THE PAR	A STATE OF THE STA	PROW/ADA:			N/A	Gutter Ponding?	Yes	N/A	Gutter Slope (%)	N/A
	Not Found, R304.2.2			N/A	Gutter Lip Ht (in)	N/A	N/A	Gutter X Slope (%)	N/A	
		ŕ			N/A	Painted X Walk1?	No	N/A	Painted X Walk2?	No
					X Walk 1 Direction	To W		X Walk 2 Direction	To S	
	是過程人一个				N/A	X Walk 1 Width (in)	N/A	N/A	X Walk 2 Width (in)	N/A
