# Access Compliance Report

## Public Rights-of-Way

### (Curb Ramps)

Intersection ID: 10772	Main Street: E_36TH_ST	Cross Street: THE_PLAZA	Location: W
ADA ID: F38BCF5F8BF0	Ramp Type: Perp	Initial Pass/Fail: Fail	Overall Compliance: No
Severity Score: 8.75			
Codes/Mitigation Info/Possible Solution		Field Measurements/Component Compliance

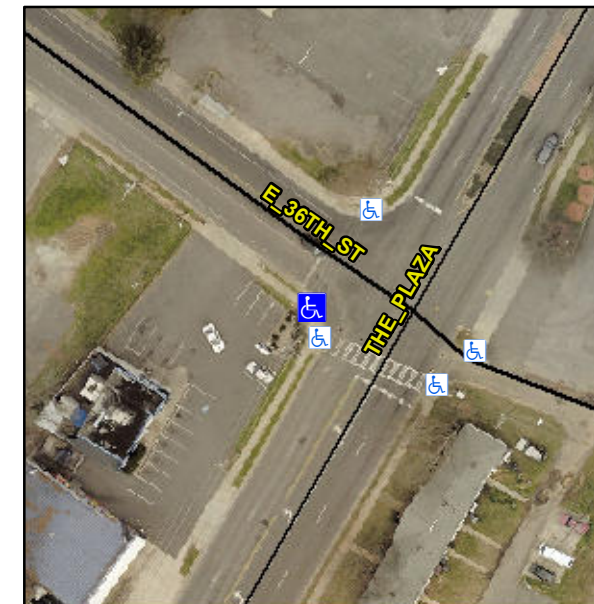
**Not Found, R304.5.1**

Compliance	Description	Data	Compliance	Description	Data
N/A	Ramp Length (in)	34.5	Yes	Ramp Slope (%)	6.8
No	Ramp Width (in)	41.0	Yes	Ramp XSlope (%)	1.4
N/A	Flare Type LT	N/A	N/A	Flare Type RT	N/A
N/A	Flare Slope LT (%)	N/A	N/A	Flare Slope RT (%)	N/A
N/A	Flare Traversable LT?	N/A	N/A	Flare Traversable RT?	N/A
N/A	Landing Length (in)	N/A	N/A	DWS Provided?	N/A
N/A	Landing Width (in)	N/A	N/A	DWS Contrast?	N/A
N/A	Landing Slope (%)	N/A	N/A	DWS Length (in)	N/A
N/A	Landing X Slope (%)	N/A	N/A	DWS Full Width?	N/A
N/A	Landing Curb? (Y/N)	N/A	N/A	DWS Offset (in)	N/A
N/A	Shared Landing?	N/A			
N/A	Gutter Ponding?	N/A	N/A	Gutter Slope (%)	N/A
N/A	Gutter Lip Ht (in)	N/A	N/A	Gutter X Slope (%)	N/A
N/A	Painted X Walk1?	Yes	N/A	Painted X Walk2?	N/A
	X Walk 1 Direction	To NE		X Walk 2 Direction	N/A
N/A	X Walk 1 Width (in)	110.5	N/A	X Walk 2 Width (in)	N/A
	X Walk 1 Slope (%)	0.5		X Walk 2 Slope (%)	N/A
	X Walk 1 X Slope (%)	0.7		X Walk 2 X Slope (%)	N/A

N/A	Ramp inside XWalk1?	Yes	N/A	Ramp inside XWalk2?	N/A
	Road Slope (%)	N/A	N/A	Clear Space?	N/A
	Road X Slope (%)	N/A	N/A	Clear Space to XWalk (in)	N/A
N/A	Any Obstructions?	N/A	N/A	Storm Grate/Utility Hazard?	N/A
	Obstruction Type			Storm Grate/Utility Type	
		N/A			N/A
		Yes		Surface Condition? (G/P)	Good

Possible Solutions:

**Remove & Replace Entire Ramp.**

Total Cost: \$ 1850.00
