Access Compliance Report

Public Rights-of-Way

(Curb Ramps)

Intersection ID: 14946	Main Street: DILWORTH RD WEST	Cross Street: E WORTHINGTON AV	Location: E
ADA ID: F38F05FDFB30	Ramp Type: Perp	Initial Pass/Fail: Fail	Overall Compliance: No
			Severity Score: 13.75

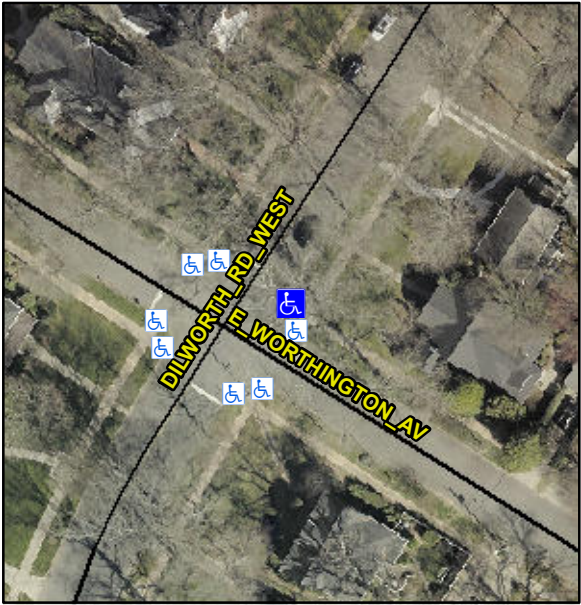
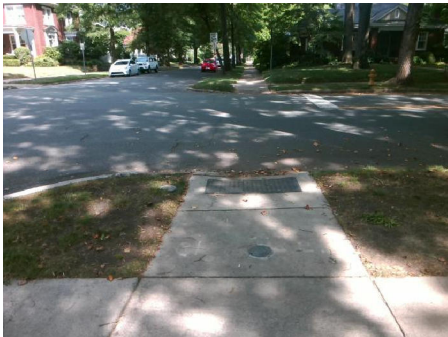
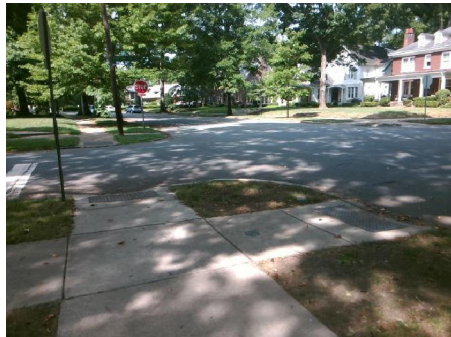
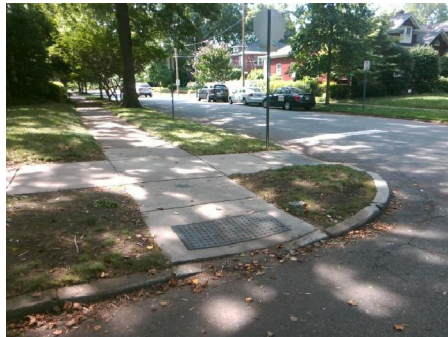
Compliance	Description	Data	Compliance	Description	Data
N/A	Ramp Length (in)	52.0	No	Ramp Slope (%)	9.1
Yes	Ramp Width (in)	48.0	No	Ramp XSlope (%)	3.3
N/A	Flare Type LT	N/A	N/A	Flare Type RT	N/A
N/A	Flare Slope LT (%)	N/A	N/A	Flare Slope RT (%)	N/A
N/A	Flare Traversable LT?	N/A	N/A	Flare Traversable RT?	N/A
N/A	Landing Length (in)	N/A	N/A	DWS Provided?	N/A
N/A	Landing Width (in)	N/A	N/A	DWS Contrast?	N/A
N/A	Landing Slope (%)	N/A	N/A	DWS Length (in)	N/A
N/A	Landing X Slope (%)	N/A	N/A	DWS Full Width?	N/A
N/A	Landing Curb? (Y/N)	N/A	N/A	DWS Offset (in)	N/A
N/A	Shared Landing?	N/A			
N/A	Gutter Ponding?	N/A	N/A	Gutter Slope (%)	N/A
N/A	Gutter Lip Ht (in)	2.0	N/A	Gutter X Slope (%)	N/A
N/A	Painted X Walk1?	No	N/A	Painted X Walk2?	N/A
	X Walk 1 Direction	To NW		X Walk 2 Direction	N/A
N/A	X Walk 1 Width (in)	N/A	N/A	X Walk 2 Width (in)	N/A
	X Walk 1 Slope (%)	4.4		X Walk 2 Slope (%)	N/A
	X Walk 1 X Slope (%)	0.7		X Walk 2 X Slope (%)	N/A

N/A	Ramp inside XWalk1?	N/A	N/A	Ramp inside XWalk2?	N/A
	Road Slope (%)	N/A	N/A	Clear Space?	N/A
	Road X Slope (%)	N/A	N/A	Clear Space to XWalk (in)	N/A
N/A	Any Obstructions?	N/A	N/A	Storm Grate/Utility Hazard?	N/A
	Obstruction Type			Storm Grate/Utility Type	
		N/A			N/A
			Yes	Surface Condition? (G/P)	Good

Possible Solutions:				
	Remove & Replace Entire Ramp.				
	Surveyor Notes:				
	N/A				
	PROW/ADA:				
	Not Found, R304.2.2, R304.5.3				
Street 1 Name	DILWORTH RD WEST				
Stop Condition-Street 2	StopSign				
Street 2 Name	N/A				
Stop Condition-Street 1	N/A				
Total Cost:		\$	1850.00
