# Access Compliance Report

## Public Rights-of-Way

### (Curb Ramps)

Intersection ID: 2934	Main Street: CHINQUAPIN_CT	Cross Street: LADY_BANK_DR	Location: NE
ADA ID: F39ED068D3FB	Ramp Type: BlendTrans1	Initial Pass/Fail: Fail	Overall Compliance: No
		Severity Score: 12.5

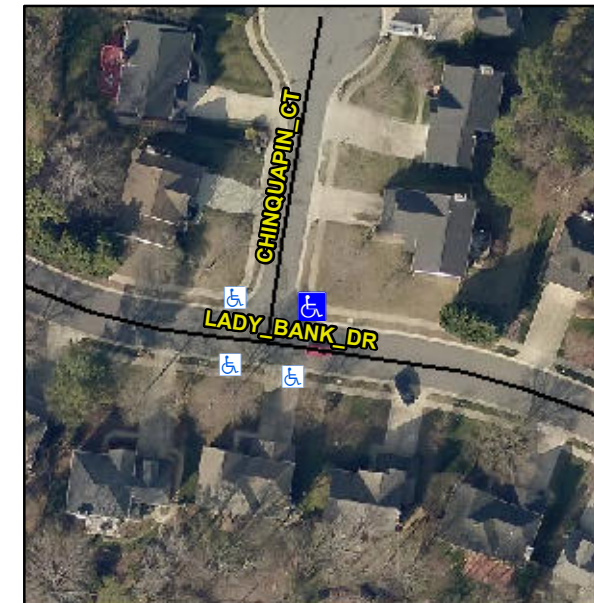
**CURB UNMODIFIED**

**Not Found, R304.5.3**

Compliance	Description	Data	Compliance	Description	Data
N/A	Ramp Length (in)	44.0	Yes	BlendTrans Slope (%)	3.7
Yes	Ramp Width (in)	48.0	No	BlendTrans XSlope (%)	5.7
N/A	Flare Type LT	N/A	N/A	Flare Type RT	N/A
N/A	Flare Slope LT (%)	N/A	N/A	Flare Slope RT (%)	N/A
N/A	Flare Traversable LT?	N/A	N/A	Flare Traversable RT?	N/A
N/A	Landing Length (in)	N/A	N/A	DWS Provided?	N/A
N/A	Landing Width (in)	N/A	N/A	DWS Contrast?	N/A
N/A	Landing Slope (%)	N/A	N/A	DWS Length (in)	N/A
N/A	Landing X Slope (%)	N/A	N/A	DWS Full Width?	N/A
N/A	Landing Curb? (Y/N)	N/A	N/A	DWS Offset (in)	N/A
N/A	Shared Landing?	N/A			
N/A	Gutter Ponding?	N/A	N/A	Gutter Slope (%)	N/A
N/A	Gutter Lip Ht (in)	N/A	N/A	Gutter X Slope (%)	N/A
N/A	Painted X Walk1?	No	N/A	Painted X Walk2?	No
	X Walk 1 Direction	To W		X Walk 2 Direction	To S
	X Walk 1 Width (in)	N/A		X Walk 2 Width (in)	N/A
	X Walk 1 Slope (%)	1.0		X Walk 2 Slope (%)	2.4
	X Walk 1 X Slope (%)	2.7		X Walk 2 X Slope (%)	3.4

N/A	Ramp inside XWalk1?	N/A	N/A	Ramp inside XWalk2?	N/A
	Road Slope (%)	6.5		Clear Space?	N/A
	Road X Slope (%)	1.3	N/A	Clear Space to XWalk (in)	N/A
N/A	Any Obstructions?	N/A	N/A	Storm Grate/Utility Hazard?	N/A
	Obstruction Type			Storm Grate/Utility Type	
		N/A			N/A
			Yes	Surface Condition? (G/P)	Good
			No	Curb Slope (%)	29.2

**Remove & Replace Curb Ramp With Two New Directional Ramps or Equivalent.**

Total Cost: \$ 3200.00
