Access Compliance Report

Public Rights-of-Way

(Curb Ramps)

Intersection ID: 10041935	Main Street: WINDING_RIVER_DR	Cross Street: N/A	Location: S
ADA ID: F3B7D9356FD6	Ramp Type: Perp	Initial Pass/Fail: Fail	Overall Compliance: No
Severity Score: 37.5			
Codes/Mitigation Info/Possible Solution		Field Measurements/Component Compliance

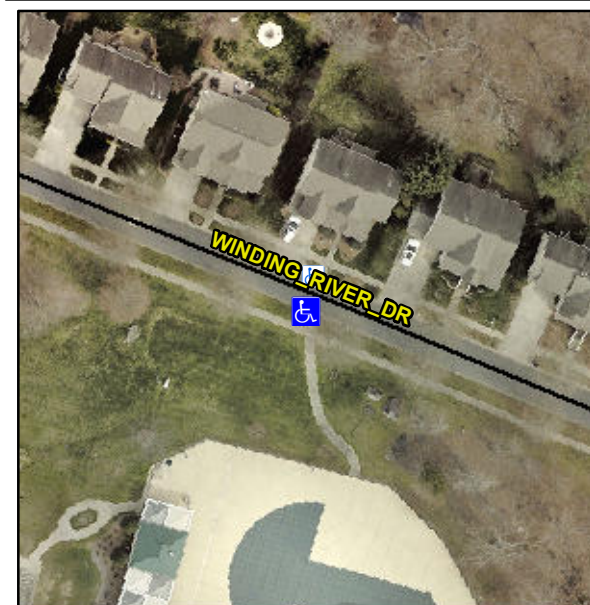
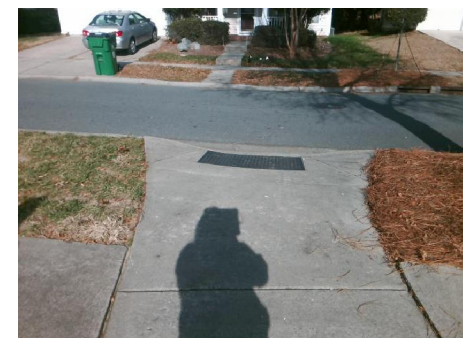
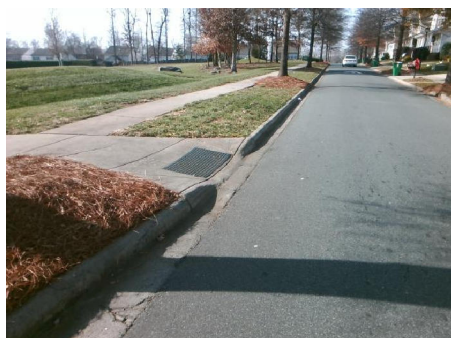
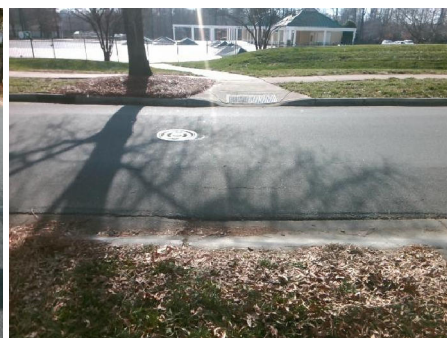
Not Found, R304.2.2, R304.5.3

Compliance	Description	Data	Compliance	Description	Data
N/A	Ramp Length (in)	43.5	No	Ramp Slope (%)	12.7
Yes	Ramp Width (in)	48.0	No	Ramp XSlope (%)	6.8
N/A	Flare Type LT	N/A	N/A	Flare Type RT	N/A
N/A	Flare Slope LT (%)	N/A	N/A	Flare Slope RT (%)	N/A
N/A	Flare Traversable LT?	N/A	N/A	Flare Traversable RT?	N/A
N/A	Landing Length (in)	N/A	N/A	DWS Provided?	N/A
N/A	Landing Width (in)	N/A	N/A	DWS Contrast?	N/A
N/A	Landing Slope (%)	N/A	N/A	DWS Length (in)	N/A
N/A	Landing X Slope (%)	N/A	N/A	DWS Full Width?	N/A
N/A	Landing Curb? (Y/N)	N/A	N/A	DWS Offset (in)	N/A
N/A	Shared Landing?	N/A			
N/A	Gutter Ponding?	N/A	N/A	Gutter Slope (%)	N/A
N/A	Gutter Lip Ht (in)	N/A	N/A	Gutter X Slope (%)	N/A
N/A	Painted X Walk1?	No	N/A	Painted X Walk2?	N/A
	X Walk 1 Direction	To N		X Walk 2 Direction	N/A
N/A	X Walk 1 Width (in)	N/A	N/A	X Walk 2 Width (in)	N/A
	X Walk 1 Slope (%)	7.1		X Walk 2 Slope (%)	N/A
	X Walk 1 X Slope (%)	1.2		X Walk 2 X Slope (%)	N/A

N/A	Ramp inside XWalk1?	N/A	N/A	Ramp inside XWalk2?	N/A
	Road Slope (%)	N/A	N/A	Clear Space?	N/A
	Road X Slope (%)	N/A	N/A	Clear Space to XWalk (in)	N/A
N/A	Any Obstructions?	N/A	N/A	Storm Grate/Utility Hazard?	N/A
	Obstruction Type			Storm Grate/Utility Type	
		N/A			N/A
			Yes	Surface Condition? (G/P)	Good

Possible Solutions:

Remove & Replace Entire Ramp.
