# Access Compliance Report

## Public Rights-of-Way

### (Curb Ramps)

Intersection ID: 15051	Main Street: FILLMORE_AV	Cross Street: KENILWORTH_AV	Location: E
ADA ID: F3C9A3B46EAE	Ramp Type: Directional1	Initial Pass/Fail: Fail	Overall Compliance: No
Severity Score: 12.5			
Codes/Mitigation Info/Possible Solution		Field Measurements/Component Compliance

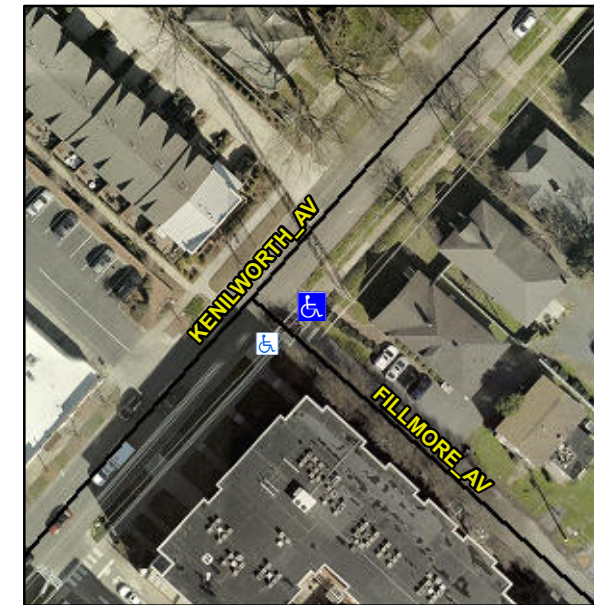
**R304.5.3**

Compliance	Description	Data	Compliance	Description	Data
N/A	Ramp Length (in)	58.0	N/A	Grade Break?	N/A
Yes	Ramp Width (in)	60.0	N/A	Grade Break Slope (%)	0.0
Yes	Ramp Slope (%)	2.2	N/A	Grade Break XSlope (%)	0.0
No	Ramp XSlope (%)	5.6			
N/A	Flare Type LT	N/A	N/A	Flare Type RT	N/A
N/A	Flare Slope LT (%)	N/A	N/A	Flare Slope RT (%)	0.0
N/A	Flare Traversable LT?	N/A	N/A	Flare Traversable RT?	N/A
N/A	Landing Length (in)	0.0	N/A	DWS Provided?	N/A
N/A	Landing Width (in)	0.0	N/A	DWS Contrast?	N/A
N/A	Landing Slope (%)	0.0	N/A	DWS Length (in)	N/A
N/A	Landing X Slope (%)	0.0	N/A	DWS Full Width?	N/A
N/A	Landing Curb? (Y/N)	N/A	N/A	DWS Offset LT (in)	N/A
N/A	Shared Landing?	N/A	N/A	DWS Offset RT (in)	N/A
N/A	Gutter Ponding?	Yes	N/A	Gutter Slope (%)	N/A
N/A	Gutter Lip Ht (in)	0.0	N/A	Gutter X Slope (%)	N/A
N/A	Painted X Walk1?	Yes		Road Slope (%)	7.9
	X Walk 1 Direction	To SW		Road X Slope (%)	3.2
	X Walk 1 Width (in)	113.0		Clear Space?	N/A

X Walk 1 Slope (%)	7.9	N/A	Clear Space to XWalk (in)	N/A
	X Walk 1 X Slope (%)	3.2	N/A	Storm Grate/Utility Hazard?	N/A
N/A	Ramp inside XWalk1?	Yes		Storm Grate/Utility Type	
N/A	Any Obstructions?	N/A			N/A
	Obstruction Type		Yes	Surface Condition? (G/P)	Good
			N/A	Curb Slope (%)	1.1

**Remove & Replace Entire Ramp.**
