## **Access Compliance Report Public Rights-of-Way** (Curb Ramps)

Intersection ID: 31673 Main Street: NEW DAY CT **Cross Street: STARSHINE DR** Location: SE **Overall Compliance: No** ADA ID: F3CFCCB0A8E5 Ramp Type: Perp Initial Pass/Fail: Fail Severity Score: 13.75

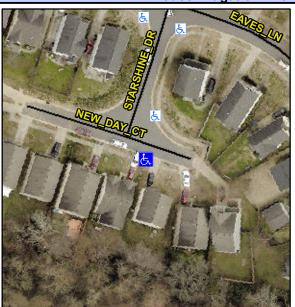
Ramp Slope (%)

Ramp XSlope (%)

Possible Solutions:	Compliance Description
Remove & Replace Entire Ramp.	N/A Ramp Length (in)
	Yes Ramp Width (in)
	N/A Flare Type LT
	N/A Flare Slope LT (%)
	<b>N/A</b> Flare Traversable L
	N/A Landing Length (in)
Surveyor Notes:	N/A Landing Width (in)
N/A	N/A Landing Slope (%)
	N/A Landing X Slope (%
	N/A Landing Curb? (Y/N
	N/A Shared Landing?
PROW/ADA:	N/A Gutter Ponding?
Not Found, R304.2.2, R304.5.3	N/A Gutter Lip Ht (in)
	N/A Painted X Walk1?
	X Walk 1 Direction
	N/A X Walk 1 Width (in)
	X Walk 1 Slope (%)
	X Walk 1 X Slope (%
	N/A Ramp inside XWalk
	Pood Slone (%)
