# Access Compliance Report

## Public Rights-of-Way

### (Curb Ramps)

Intersection ID: 10042346	Main Street: WRANGELL_LN	Cross Street: N/A	Location: E
ADA ID: F3DEF9E63A77	Ramp Type: BlendTrans1	Initial Pass/Fail: Fail	Overall Compliance: No
		Severity Score: 10

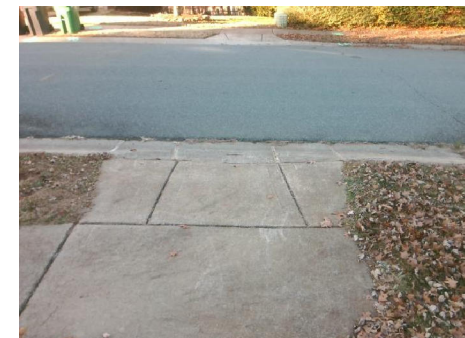
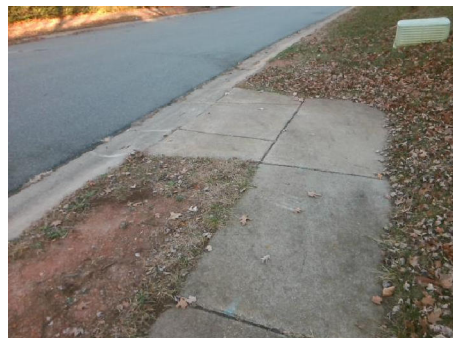
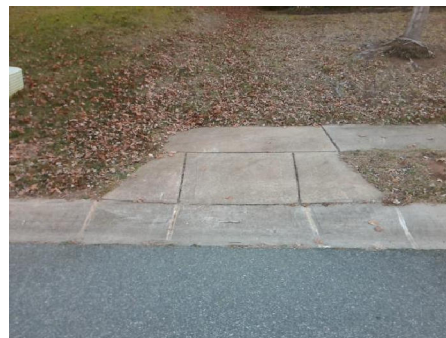
**NO LT SW**

**Not Found, R304.5.1, R304.5.3**

Compliance	Description	Data	Compliance	Description	Data
N/A	Ramp Length (in)	48.0	Yes	BlendTrans Slope (%)	4.4
No	Ramp Width (in)	44.0	No	BlendTrans XSlope (%)	4.7
N/A	Flare Type LT	N/A	N/A	Flare Type RT	N/A
N/A	Flare Slope LT (%)	N/A	N/A	Flare Slope RT (%)	N/A
N/A	Flare Traversable LT?	N/A	N/A	Flare Traversable RT?	N/A
N/A	Landing Length (in)	N/A	N/A	DWS Provided?	N/A
N/A	Landing Width (in)	N/A	N/A	DWS Contrast?	N/A
N/A	Landing Slope (%)	N/A	N/A	DWS Length (in)	N/A
N/A	Landing X Slope (%)	N/A	N/A	DWS Full Width?	N/A
N/A	Landing Curb? (Y/N)	N/A	N/A	DWS Offset (in)	N/A
N/A	Shared Landing?	N/A			
N/A	Gutter Ponding?	N/A	N/A	Gutter Slope (%)	N/A
N/A	Gutter Lip Ht (in)	1.0	N/A	Gutter X Slope (%)	N/A
N/A	Painted X Walk1?	No	N/A	Painted X Walk2?	N/A
	X Walk 1 Direction	To W		X Walk 2 Direction	N/A
	X Walk 1 Width (in)	N/A		X Walk 2 Width (in)	N/A
	X Walk 1 Slope (%)	4.0		X Walk 2 Slope (%)	N/A
	X Walk 1 X Slope (%)	3.5		X Walk 2 X Slope (%)	N/A

N/A	Ramp inside XWalk1?	N/A	N/A	Ramp inside XWalk2?	N/A
	Road Slope (%)	3.5		Clear Space?	N/A
	Road X Slope (%)	4.0	N/A	Clear Space to XWalk (in)	N/A
N/A	Any Obstructions?	N/A	N/A	Storm Grate/Utility Hazard?	N/A
	Obstruction Type			Storm Grate/Utility Type	
		N/A			N/A
			Yes	Surface Condition? (G/P)	Good
			No	Curb Slope (%)	6.4

**Remove & Replace Curb Ramp With Two New Directional Ramps or Equivalent.**
