Access Compliance Report

Public Rights-of-Way

(Curb Ramps)

Intersection ID: 15153	Main Street: GRIFFITH_ST	Cross Street: POINDEXTER_DR	Location: SE
ADA ID: F3E508495E08	Ramp Type: Perp	Initial Pass/Fail: Fail	Overall Compliance: No
Codes/Mitigation Info/Possible Solution		Field Measurements/Component Compliance	
Severity Score: 21.25

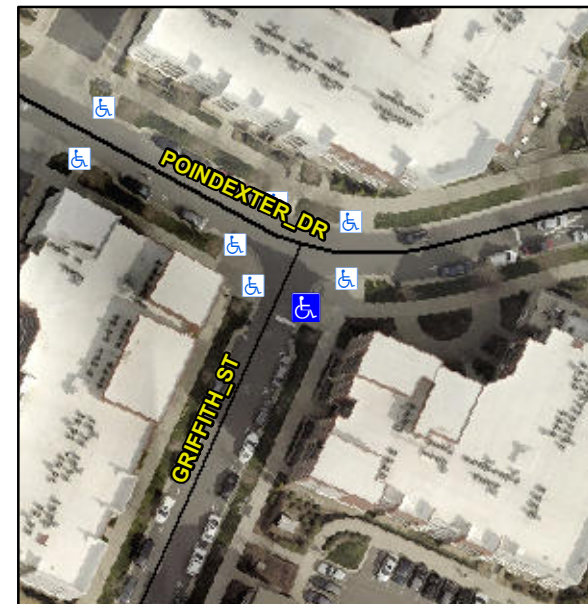
Not Found, R304.5.1, R304.2.2

Compliance	Description	Data	Compliance	Description	Data
N/A	Ramp Length (in)	72.0	No	Ramp Slope (%)	11.6
No	Ramp Width (in)	47.0	Yes	Ramp XSlope (%)	1.6
N/A	Flare Type LT	N/A	N/A	Flare Type RT	N/A
N/A	Flare Slope LT (%)	N/A	N/A	Flare Slope RT (%)	N/A
N/A	Flare Traversable LT?	N/A	N/A	Flare Traversable RT?	N/A
N/A	Landing Length (in)	N/A	N/A	DWS Provided?	N/A
N/A	Landing Width (in)	N/A	N/A	DWS Contrast?	N/A
N/A	Landing Slope (%)	N/A	N/A	DWS Length (in)	N/A
N/A	Landing X Slope (%)	N/A	N/A	DWS Full Width?	N/A
N/A	Landing Curb? (Y/N)	N/A	N/A	DWS Offset (in)	N/A
N/A	Shared Landing?	N/A			
N/A	Gutter Ponding?	N/A	N/A	Gutter Slope (%)	N/A
N/A	Gutter Lip Ht (in)	N/A	N/A	Gutter X Slope (%)	N/A
N/A	Painted X Walk1?	No	N/A	Painted X Walk2?	N/A
	X Walk 1 Direction	To NW		X Walk 2 Direction	N/A
N/A	X Walk 1 Width (in)	N/A	N/A	X Walk 2 Width (in)	N/A
	X Walk 1 Slope (%)	0.6		X Walk 2 Slope (%)	N/A
	X Walk 1 X Slope (%)	2.1		X Walk 2 X Slope (%)	N/A

Possible Solutions:

Remove & Replace Entire Ramp.
