# Access Compliance Report

## Public Rights-of-Way

### (Curb Ramps)

Intersection ID: N/A	Main Street: WALNUT_LOOP_RD	Cross Street: MARSHALL_BRIDGE_RD	Location: SE
ADA ID: F3EEEE5515D3	Ramp Type: Perp	Initial Pass/Fail: Fail	Overall Compliance: No
Severity Score: 12.5			
Codes/Mitigation Info/Possible Solution		Field Measurements/Component Compliance

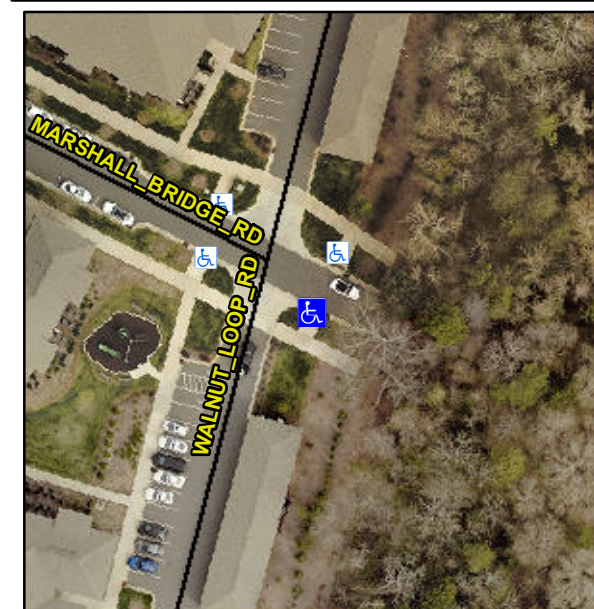
**Not Found, R304.2.2**

Compliance	Description	Data	Compliance	Description	Data
N/A	Ramp Length (in)	155.0	No	Ramp Slope (%)	9.0
Yes	Ramp Width (in)	93.0	Yes	Ramp XSlope (%)	1.6
N/A	Flare Type LT	N/A	N/A	Flare Type RT	N/A
N/A	Flare Slope LT (%)	N/A	N/A	Flare Slope RT (%)	N/A
N/A	Flare Traversable LT?	N/A	N/A	Flare Traversable RT?	N/A
N/A	Landing Length (in)	N/A	N/A	DWS Provided?	N/A
N/A	Landing Width (in)	N/A	N/A	DWS Contrast?	N/A
N/A	Landing Slope (%)	N/A	N/A	DWS Length (in)	N/A
N/A	Landing X Slope (%)	N/A	N/A	DWS Full Width?	N/A
N/A	Landing Curb? (Y/N)	N/A	N/A	DWS Offset (in)	N/A
N/A	Shared Landing?	N/A			
N/A	Gutter Ponding?	N/A	N/A	Gutter Slope (%)	N/A
N/A	Gutter Lip Ht (in)	N/A	N/A	Gutter X Slope (%)	N/A
N/A	Painted X Walk1?	No	N/A	Painted X Walk2?	N/A
	X Walk 1 Direction	To NE		X Walk 2 Direction	N/A
N/A	X Walk 1 Width (in)	N/A	N/A	X Walk 2 Width (in)	N/A
	X Walk 1 Slope (%)	3.9		X Walk 2 Slope (%)	N/A
	X Walk 1 X Slope (%)	0.5		X Walk 2 X Slope (%)	N/A

**Remove & Replace Entire Ramp.**

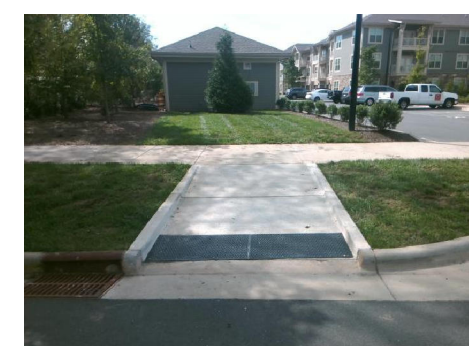
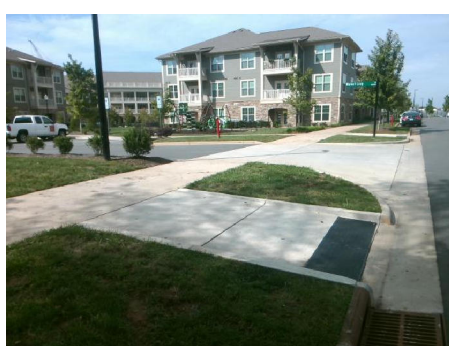
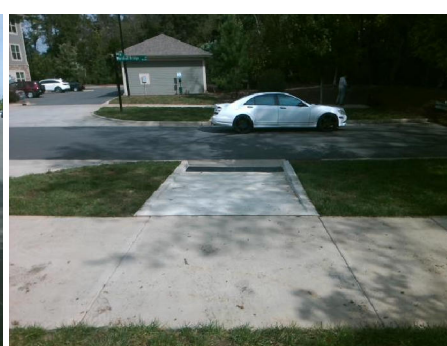
N/A	Ramp inside XWalk1?	N/A	N/A	Ramp inside XWalk2?	N/A
	Road Slope (%)	N/A	N/A	Clear Space?	N/A
	Road X Slope (%)	N/A	N/A	Clear Space to XWalk (in)	N/A
N/A	Any Obstructions?	N/A	N/A	Storm Grate/Utility Hazard?	N/A
	Obstruction Type			Storm Grate/Utility Type	
		N/A			N/A
			Yes	Surface Condition? (G/P)	Good
