# Access Compliance Report

## Public Rights-of-Way

### (Curb Ramps)

Intersection ID: 3180	Main Street: JOHNSTON_OEHLE_R_D	Cross Street: SONG_SPARROW_LN	Location:	S
ADA ID: F3FA3788974F	Ramp Type: Perp	Initial Pass/Fail: Fail	Overall Compliance: No	Severity Score: 25
Codes/Mitigation Info/Possible Solution		Field Measurements/Component Compliance

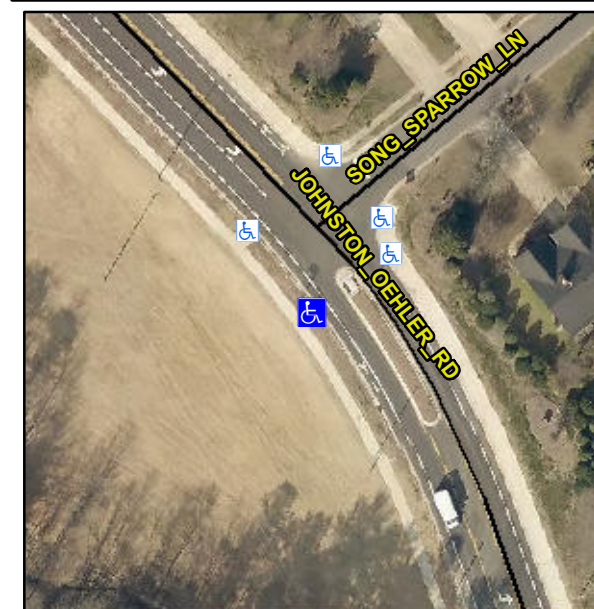
Compliance	Description	Data	Compliance	Description	Data
N/A	Ramp Length (in)	95.5	No	Ramp Slope (%)	13.2
Yes	Ramp Width (in)	95.0	Yes	Ramp XSlope (%)	1.5
N/A	Flare Type LT	N/A	N/A	Flare Type RT	N/A
N/A	Flare Slope LT (%)	N/A	N/A	Flare Slope RT (%)	N/A
N/A	Flare Traversable LT?	N/A	N/A	Flare Traversable RT?	N/A
N/A	Landing Length (in)	N/A	N/A	DWS Provided?	N/A
N/A	Landing Width (in)	N/A	N/A	DWS Contrast?	N/A
N/A	Landing Slope (%)	N/A	N/A	DWS Length (in)	N/A
N/A	Landing X Slope (%)	N/A	N/A	DWS Full Width?	N/A
N/A	Landing Curb? (Y/N)	N/A	N/A	DWS Offset (in)	N/A
N/A	Shared Landing?	N/A			
N/A	Gutter Ponding?	N/A	N/A	Gutter Slope (%)	N/A
N/A	Gutter Lip Ht (in)	N/A	N/A	Gutter X Slope (%)	N/A
N/A	Painted X Walk1?	No	N/A	Painted X Walk2?	N/A
	X Walk 1 Direction	To NE		X Walk 2 Direction	N/A
N/A	X Walk 1 Width (in)	N/A	N/A	X Walk 2 Width (in)	N/A
	X Walk 1 Slope (%)	1.4		X Walk 2 Slope (%)	N/A
	X Walk 1 X Slope (%)	1.3		X Walk 2 X Slope (%)	N/A

N/A	Ramp inside XWalk1?	N/A	N/A	Ramp inside XWalk2?	N/A
	Road Slope (%)	N/A	N/A	Clear Space?	N/A
	Road X Slope (%)	N/A	N/A	Clear Space to XWalk (in)	N/A
N/A	Any Obstructions?	N/A	N/A	Storm Grate/Utility Hazard?	N/A
	Obstruction Type			Storm Grate/Utility Type	
		N/A			N/A
			Yes	Surface Condition? (G/P)	Good

**Remove & Replace Entire Ramp.**

**R304.2.2**

**\$ 1850.00**
