Access Compliance Report

Public Rights-of-Way

(Curb Ramps)

Intersection ID: 43655	Main Street: HUNTINGTON_MEADOW_LN	Cross Street: KELLINGTON_CT	Location: SE
ADA ID: F402A31F7ECE	Ramp Type: Perp	Initial Pass/Fail: Fail	Overall Compliance: No
Severity Score: 25			
Codes/Mitigation Info/Possible Solution		Field Measurements/Component Compliance

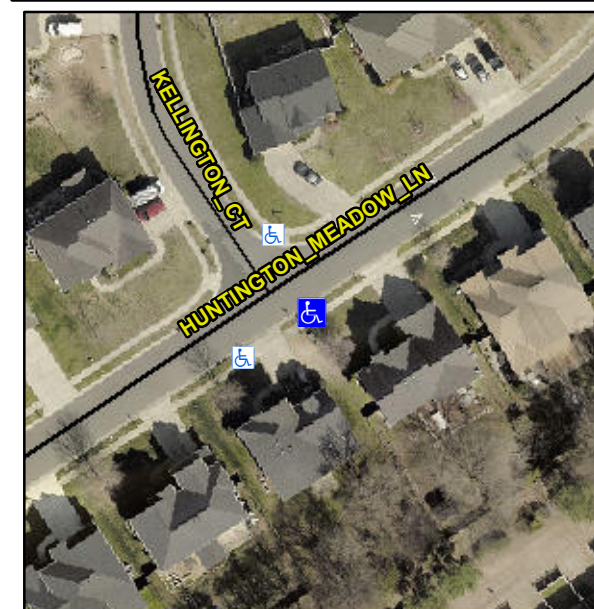
Not Found, R304.2.2

Compliance	Description	Data	Compliance	Description	Data
N/A	Ramp Length (in)	46.0	No	Ramp Slope (%)	12.7
Yes	Ramp Width (in)	54.0	Yes	Ramp XSlope (%)	1.1
N/A	Flare Type LT	N/A	N/A	Flare Type RT	N/A
N/A	Flare Slope LT (%)	N/A	N/A	Flare Slope RT (%)	N/A
N/A	Flare Traversable LT?	N/A	N/A	Flare Traversable RT?	N/A
N/A	Landing Length (in)	N/A	N/A	DWS Provided?	N/A
N/A	Landing Width (in)	N/A	N/A	DWS Contrast?	N/A
N/A	Landing Slope (%)	N/A	N/A	DWS Length (in)	N/A
N/A	Landing X Slope (%)	N/A	N/A	DWS Full Width?	N/A
N/A	Landing Curb? (Y/N)	N/A	N/A	DWS Offset (in)	N/A
N/A	Shared Landing?	N/A			
N/A	Gutter Ponding?	N/A	N/A	Gutter Slope (%)	N/A
N/A	Gutter Lip Ht (in)	N/A	N/A	Gutter X Slope (%)	N/A
N/A	Painted X Walk1?	No	N/A	Painted X Walk2?	N/A
	X Walk 1 Direction	To N		X Walk 2 Direction	N/A
N/A	X Walk 1 Width (in)	N/A	N/A	X Walk 2 Width (in)	N/A
	X Walk 1 Slope (%)	3.4		X Walk 2 Slope (%)	N/A
	X Walk 1 X Slope (%)	1.0		X Walk 2 X Slope (%)	N/A

Remove & Replace Entire Ramp.

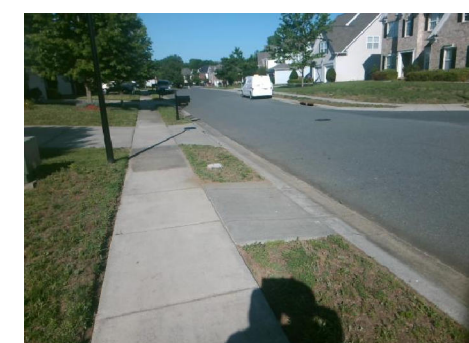
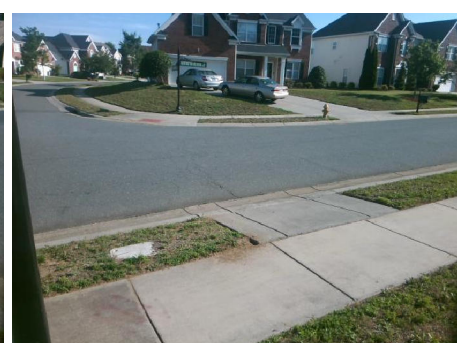
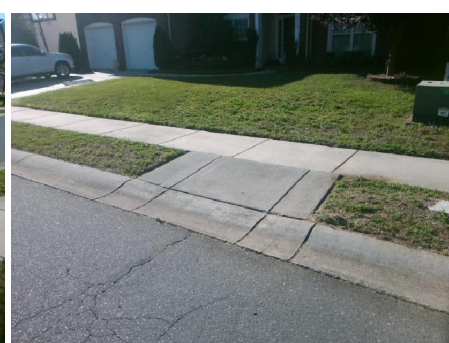
N/A	Ramp inside XWalk1?	N/A	N/A	Ramp inside XWalk2?	N/A
	Road Slope (%)	N/A	N/A	Clear Space?	N/A
	Road X Slope (%)	N/A	N/A	Clear Space to XWalk (in)	N/A
N/A	Any Obstructions?	N/A	N/A	Storm Grate/Utility Hazard?	N/A
	Obstruction Type			Storm Grate/Utility Type	
		N/A			N/A
			Yes	Surface Condition? (G/P)	Good
