Access Compliance Report Public Rights-of-Way (Curb Ramps)

0	0				1 (
Intersection ID: 20702	Main Street: ARCHDALE_DR		Cross	Cross Street: PARKSTONE_DR				Location:	NW	
ADA ID: F4187D80D382	82 Ramp Type: PerpDiag		Initial	Initial Pass/Fail: Fail Overall Compliance: N			o Severity Score:	48.75		
Codes/Mitigation Info/Possible Solution					Field Measurements/Component Compliance					
		Possible Solutions:		Compliance Description			Data Compliance Description			
		Remove & Replace Curb Ramp Wi Two New Directional Ramps or Equivalent.	o With	N/A	Ramp Length (in)	106.0	No	Ramp Slope (%)	9.4	
			r	No	Ramp Width (in)	28.0	No	Ramp XSlope (%)	4.5	
				N/A	Flare Type LT	N/A	N/A	Flare Type RT	N/A	
				N/A	Flare Slope LT (%)	N/A	N/A	Flare Slope RT (%)	N/A	
				N/A	Flare Traversable LT?	N/A	N/A	Flare Traversable RT?	N/A	
				N/A	Landing Length (in)	N/A	N/A	DWS Provided?	N/A	
AROTOMIA		Surveyor Notes:		N/A	Landing Width (in)	N/A	N/A	DWS Contrast?	N/A	
		N/A		N/A	Landing Slope (%)	N/A	N/A	DWS Length (in)	N/A

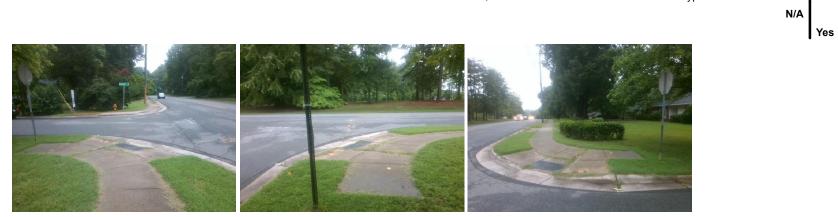
N/A	Landing X Slope (%)	N/A	N/A	DWS Full Width?	N/A	
				N/A	Landing Curb? (Y/N)	N/A	N/A	DWS Offset (in)	N/A	
N. S. M. S. S. B. B.				N/A	Shared Landing?	N/A				
E State A Maria	The states	PROW/ADA:		N/A	Gutter Ponding?	N/A	N/A	Gutter Slope (%)	N/A	
A Martin Martin Martin	1 mm 2 12	R304.5.1, R304.2.2, R304.5.3		N/A	Gutter Lip Ht (in)	N/A	N/A	Gutter X Slope (%)	N/A	
	and the second	,,		N/A	Painted X Walk1?	No	N/A	Painted X Walk2?	No	
					X Walk 1 Direction	To S		X Walk 2 Direction	To E	
and the Car				N/A	X Walk 1 Width (in)	N/A	N/A	X Walk 2 Width (in)	N/A	
Street 1 Name	ARCHDALE DR	-			X Walk 1 Slope (%)	10.5		X Walk 2 Slope (%)	1.6	
Stop Condition-Street 2	None				X Walk 1 X Slope (%)	3.2		X Walk 2 X Slope (%)	6.0	
Street 2 Name	PARKSTONE DR			N/A	Ramp inside XWalk1?	N/A	N/A	Ramp inside XWalk2?	N/A	
Stop Condition-Street 1	StopSign				Road Slope (%)	3.6	N/A	Clear Space?	N/A

-				Road X Slope (%)	7.8	N/A	Clear Space to XWalk (in)	N/A	
				N/A	Any Obstructions?	N/A	N/A	Storm Grate/Utility Hazard?	N/A	
		Total Cost: \$	3200.00		Obstruction Type			Storm Grate/Utility Type		
						N/A			N/A	
1
