# Access Compliance Report

## Public Rights-of-Way

### (Curb Ramps)

| ADA ID: F41EB412A772 | Ramp Type: BlendTrans1 | Initial Pass/Fail: Fail | Overall Compliance: No |

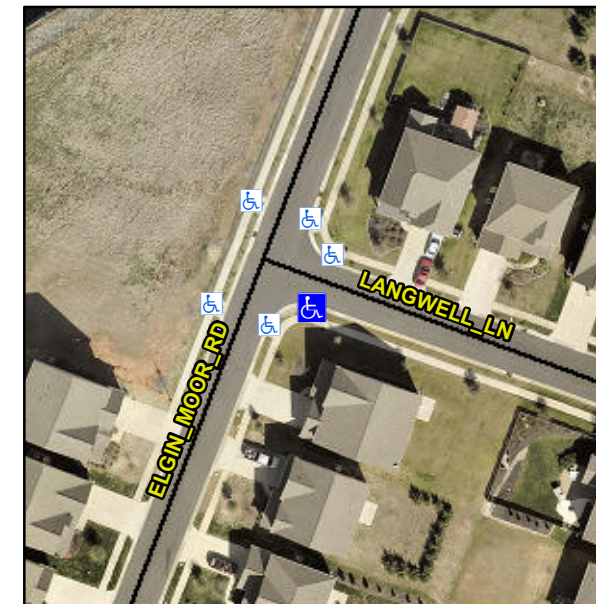
**Not Found, R304.5.1**

| Compliance | Description | Data | Compliance | Description | Data |
|---|---|---|---|---|---|
| No | Ramp Width (in) | 46.0 | Yes | BlendTrans XSlope (%) | 0.7 |
| | | | No | Curb Slope (%) | 6.5 |

**Remove & Replace Curb Ramp With Two New Directional Ramps or Equivalent.**

Total Cost: \$ 3200.00

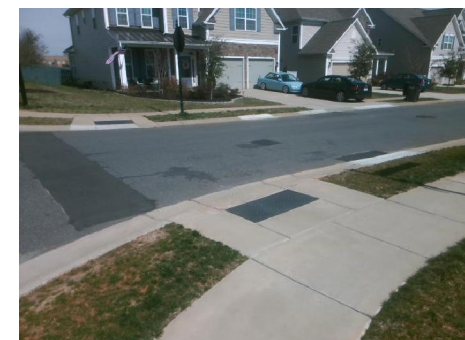
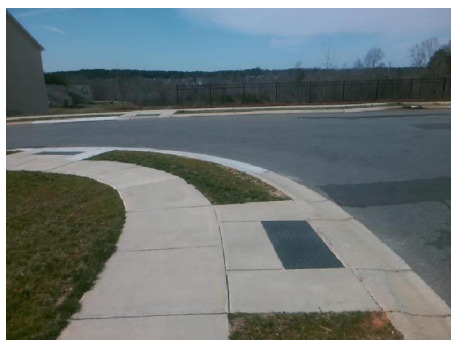
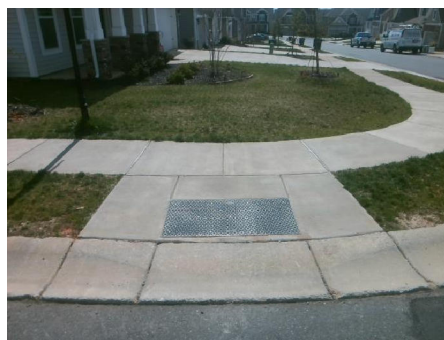
Street 1 Name LANGWELL LN  
 Stop Condition-Street 1 StopSign  
 Street 2 Name N/A  
 Stop Condition-Street 2 N/A
