Access Compliance Report

Public Rights-of-Way

(Curb Ramps)

Intersection ID: 21664	Main Street: RED_ROCK_RD	Cross Street: SARDIS_RD_NORTH	Location: SE
ADA ID: F4229FC06DEB	Ramp Type: PerpDiag	Initial Pass/Fail: Fail	Overall Compliance: No
Severity Score: 13.75			
Codes/Mitigation Info/Possible Solution		Field Measurements/Component Compliance

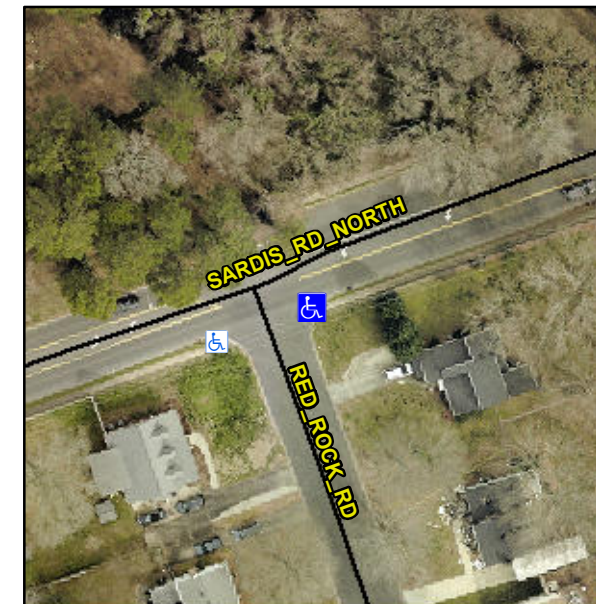
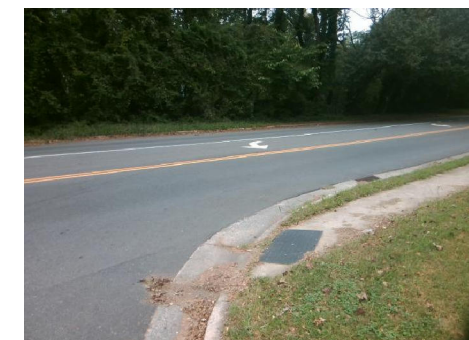
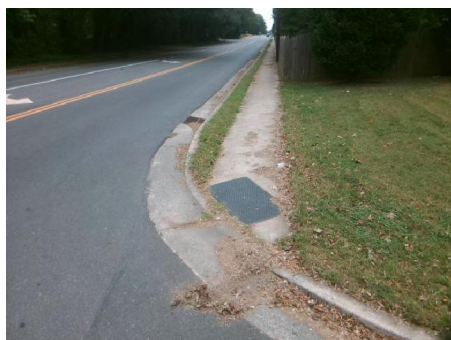
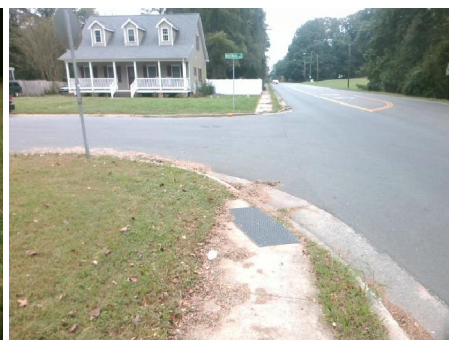
Compliance	Description	Data	Compliance	Description	Data
N/A	Ramp Length (in)	38.0	No	Ramp Slope (%)	9.4
Yes	Ramp Width (in)	48.0	No	Ramp XSlope (%)	3.4
N/A	Flare Type LT	N/A	N/A	Flare Type RT	N/A
N/A	Flare Slope LT (%)	N/A	N/A	Flare Slope RT (%)	N/A
N/A	Flare Traversable LT?	N/A	N/A	Flare Traversable RT?	N/A
N/A	Landing Length (in)	N/A	N/A	DWS Provided?	N/A
N/A	Landing Width (in)	N/A	N/A	DWS Contrast?	N/A
N/A	Landing Slope (%)	N/A	N/A	DWS Length (in)	N/A
N/A	Landing X Slope (%)	N/A	N/A	DWS Full Width?	N/A
N/A	Landing Curb? (Y/N)	N/A	N/A	DWS Offset (in)	N/A
N/A	Shared Landing?	N/A			
N/A	Gutter Ponding?	N/A	N/A	Gutter Slope (%)	N/A
N/A	Gutter Lip Ht (in)	N/A	N/A	Gutter X Slope (%)	N/A
N/A	Painted X Walk1?	No	N/A	Painted X Walk2?	No
	X Walk 1 Direction	To N		X Walk 2 Direction	To W
N/A	X Walk 1 Width (in)	N/A	N/A	X Walk 2 Width (in)	N/A
	X Walk 1 Slope (%)	3.7		X Walk 2 Slope (%)	3.1
	X Walk 1 X Slope (%)	4.1		X Walk 2 X Slope (%)	0.3

N/A	Ramp inside XWalk1?	N/A	N/A	Ramp inside XWalk2?	N/A
	Road Slope (%)	2.9	N/A	Clear Space?	N/A
	Road X Slope (%)	5.3	N/A	Clear Space to XWalk (in)	N/A
N/A	Any Obstructions?	N/A	N/A	Storm Grate/Utility Hazard?	N/A
	Obstruction Type			Storm Grate/Utility Type	
		N/A			N/A
		Yes		Surface Condition? (G/P)	Good

Possible Solutions:

Remove & Replace Curb Ramp With Two New Directional Ramps or Equivalent.

R304.2.2, R304.5.3
