Access Compliance Report

Public Rights-of-Way

(Curb Ramps)

| Intersection ID: 3137 | Main Street: ALAMEDA_LN | Cross Street: STONE_PARK_DR | Location: NW |

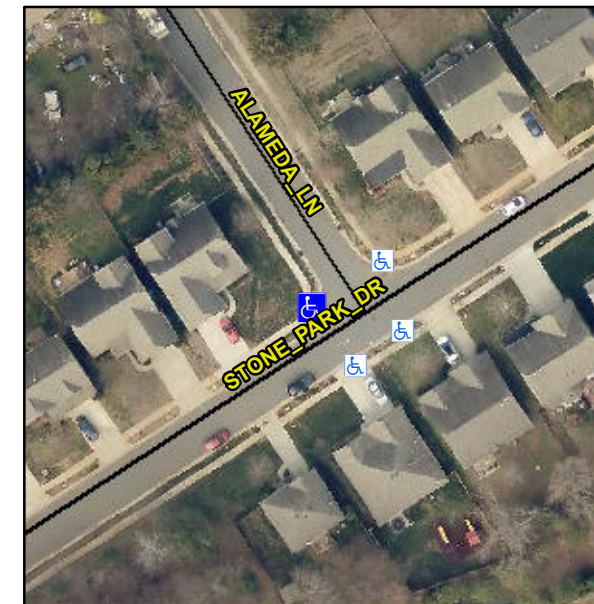
| ADA ID: F4305CA0EF0B | Ramp Type: PerpDiag | Initial Pass/Fail: Fail | Overall Compliance: No |
| Severity Score: 22.5 | | | |

Not Found, R304.5.1, R304.2.2, R304.5.3

| Compliance | Description | Data | Compliance | Description | Data |
|---|---|---|---|---|---|
| N/A | Ramp Length (in) | 48.5 | No | Ramp Slope (%) | 8.4 |
| No | Ramp Width (in) | 39.0 | No | Ramp XSlope (%) | 3.5 |

Remove & Replace Curb Ramp With Two New Directional Ramps or Equivalent.

Total Cost: \$ 3200.00
