Access Compliance Report

Public Rights-of-Way

(Curb Ramps)

Intersection ID: 8874	Main Street: MONTREAT_ST	Cross Street: NORRIS_AV	Location: NW
ADA ID: F438A8865D34	Ramp Type: Para	Initial Pass/Fail: Fail	Overall Compliance: No
Codes/Mitigation Info/Possible Solution		Field Measurements/Component Compliance

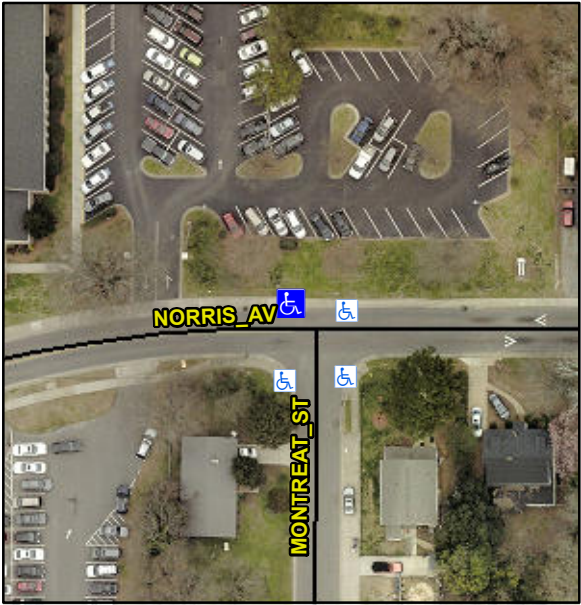
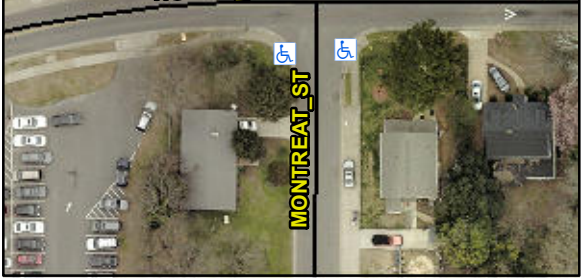
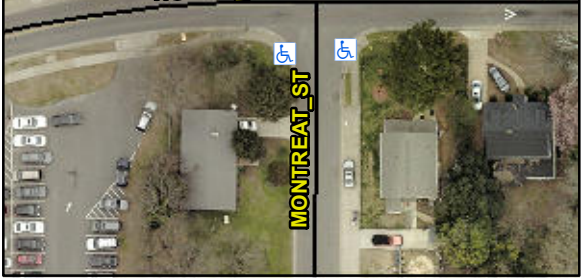
PROW/ADA:			
	R304.3.2, R304.5.3			
Street 1 Name	NORRIS AV			
Stop Condition-Street 1	None			
Street 2 Name	N/A			
Stop Condition-Street 2	N/A			
Total Cost:		\$	1600.00

Compliance	Description	Data	Compliance	Description	Data
N/A	Ramp Length LT (in)	72.0	N/A	Ramp Length RT (in)	N/A
Yes	Ramp Width LT (in)	56.0	N/A	Ramp Width RT (in)	N/A
No	Ramp Slope LT (%)	8.5	N/A	Ramp Slope RT (%)	N/A
No	Ramp XSlope LT (%)	3.3	N/A	Ramp XSlope RT (%)	N/A
N/A	Landing Length (in)	N/A	N/A	DWS Provided?	N/A
N/A	Landing Width (in)	N/A	N/A	DWS Contrast?	N/A
N/A	Landing Slope (%)	N/A	N/A	DWS Length (in)	N/A
N/A	Landing X Slope (%)	N/A	N/A	DWS Full Width?	N/A
N/A	Landing Curb? (Y/N)	N/A	N/A	DWS Offset (in)	N/A
N/A	Shared Landing?	N/A			
N/A	Gutter Ponding?	N/A	N/A	Gutter Slope (%)	N/A
N/A	Gutter Lip Ht (in)	N/A	N/A	Gutter X Slope (%)	N/A
N/A	Painted X Walk1?	No	N/A	Painted X Walk2?	N/A
	X Walk 1 Direction	To S		X Walk 2 Direction	N/A
N/A	X Walk 1 Width (in)	N/A	N/A	X Walk 2 Width (in)	N/A
	X Walk 1 Slope (%)	4.7		X Walk 2 Slope (%)	N/A
	X Walk 1 X Slope (%)	1.2		X Walk 2 X Slope (%)	N/A
N/A	Ramp inside XWalk1?	N/A	N/A	Ramp inside XWalk2?	N/A

Road Slope (%)	N/A	N/A	Clear Space?	N/A
	Road X Slope (%)	N/A	N/A	Clear Space to XWalk (in)	N/A
N/A	Any Obstructions?	N/A	N/A	Storm Grate/Utility Hazard?	N/A
	Obstruction Type			Storm Grate/Utility Type	
		N/A			N/A
			Yes	Surface Condition? (G/P)	Good
			N/A	Curb Slope (%)	22.4

Possible Solutions:			
	Remove & Replace Entire Ramp.
