Access Compliance Report

Public Rights-of-Way

(Curb Ramps)

| Intersection ID: 28727 | Main Street: STEWARTS_CROSSING_DR | Cross Street: TRESHAM_CT | Location: | E |

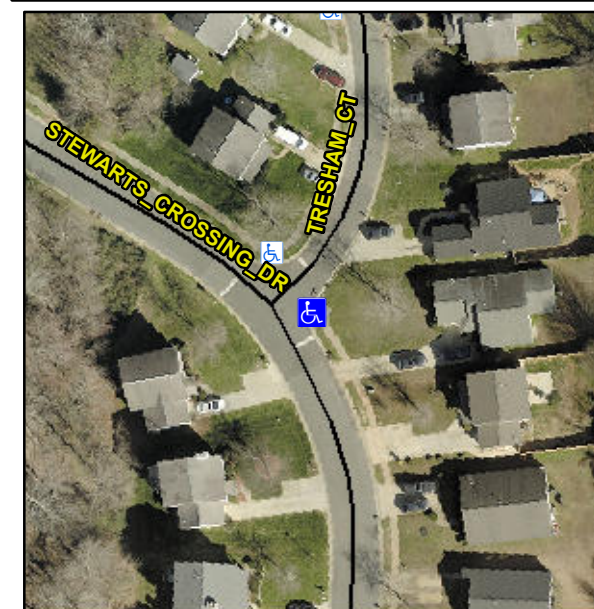
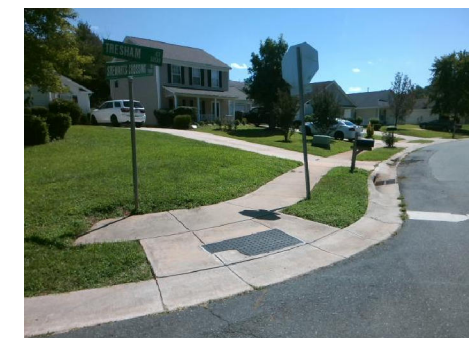
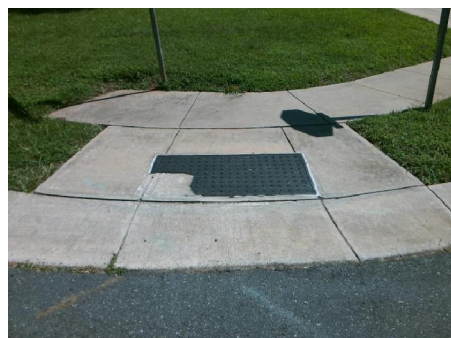
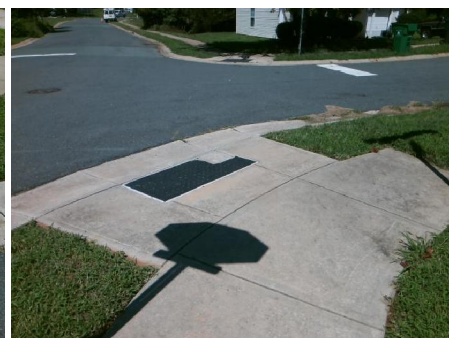
| ADA ID: F4484E328191 | Ramp Type: Perp | Initial Pass/Fail: Fail | Overall Compliance: No | Severity Score: 8.75 |

R304.5.1

| Compliance | Description | Data | Compliance | Description | Data |
|---|---|---|---|---|---|
| No | Ramp Width (in) | 38.5 | Yes | Ramp XSlope (%) | 0.7 |

Remove & Replace Entire Ramp.

Total Cost: \$ 1850.00
