Access Compliance Report Public Rights-of-Way (Curb Ramps)

Intersection ID: 50203 Main Street: WEDDINGTON_RD **Cross Street: COLTSVIEW LN** Location: SW ADA ID: F4557D43F71D Ramp Type: BlendTrans1 Initial Pass/Fail: Fail **Overall Compliance: No Severity Score:** 8.75

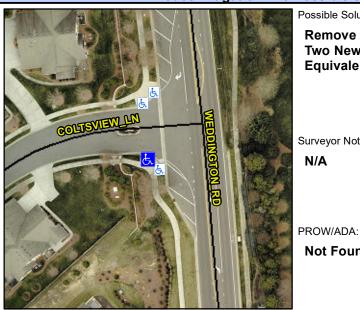
Field Measurements/Component Compliance						
Compliance Description		Data	Comp	liance	Description	Data
N/A	Ramp Length (in)	97.0	Yes	Blend	dTrans Slope (%)	4.7
No	Ramp Width (in)	47.5	Yes BlendTrans XSlope (%)		1.5	
N/A	Flare Type LT	N/A	N/A Flare Type RT		N/A	
N/A	Flare Slope LT (%)	N/A	N/A Flare Slope RT (%)		N/A	
N/A	Flare Traversable LT?	N/A	N/A	N/A Flare Traversable RT?		N/A
N/A	Landing Length (in)	N/A	N/A	DWS	Provided?	N/A
N/A	Landing Width (in)	N/A	N/A	DWS	Contrast?	N/A
N/A	Landing Slope (%)	N/A	N/A	DWS	Length (in)	N/A
N/A	Landing X Slope (%)	N/A	N/A	DWS	Full Width?	N/A
N/A	Landing Curb? (Y/N)	N/A	N/A	DWS	Offset (in)	N/A
N/A	Shared Landing?	N/A				
N/A	Gutter Ponding?	N/A	N/A	Gutte	er Slope (%)	N/A
N/A	Gutter Lip Ht (in)	N/A	N/A	Gutte	er X Slope (%)	N/A
N/A	Painted X Walk1?	No	N/A	Paint	ed X Walk2?	N/A
	X Walk 1 Direction	To N		X Wa	lk 2 Direction	N/A
	X Walk 1 Width (in)	N/A		X Wa	ılk 2 Width (in)	N/A

X Walk 1 Slope (%)	1.9		X Wa	ılk 2 Slope (%)	N/A
	X Walk 1 X Slope (%)	3.4		X Wa	ılk 2 X Slope (%)	N/A
N/A	Ramp inside XWalk1?	N/A	N/A	Ram	p inside XWalk2?	N/A
	Road Slope (%)	3.4		Clear	Space?	N/A
	Road X Slope (%)	1.9	N/A	Clear	Space to XWalk (in)	N/A
N/A	Any Obstructions?	N/A	N/A	Storn	n Grate/Utility Hazard?	N/A
	Obstruction Type			Storn	n Grate/Utility Type	
		N/A				N/A
			Yes	Surfa	ice Condition? (G/P)	Good
			No	Curb	Slope (%)	10.1

COLTSVIEW LN Street 1 Name Stop Condition-Street 1 StopSign Street 2 Name N/A Stop Condition-Street 2 N/A Possible Solutions: Remove & Replace Curb Ramp With **Two New Directional Ramps or** Equivalent. Surveyor Notes: N/A
