# Access Compliance Report

## Public Rights-of-Way

### (Curb Ramps)

Intersection ID: 31349	Main Street: OAK_PASTURE_LN	Cross Street: SAGUARO_CT	Location: W
ADA ID: F45AFD3D5478	Ramp Type: PerpDiag	Initial Pass/Fail: Fail	Overall Compliance: No
Severity Score: 30			
Codes/Mitigation Info/Possible Solution		Field Measurements/Component Compliance

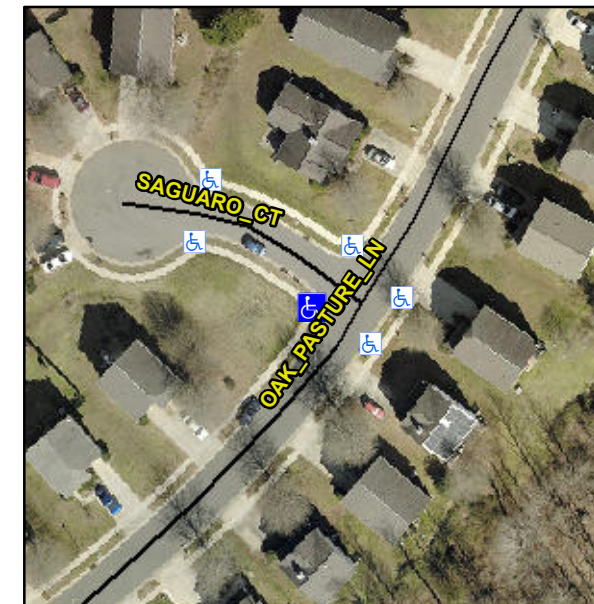
Compliance	Description	Data	Compliance	Description	Data
N/A	Ramp Length (in)	48.0	No	Ramp Slope (%)	9.8
No	Ramp Width (in)	32.0	Yes	Ramp XSlope (%)	1.6
N/A	Flare Type LT	N/A	N/A	Flare Type RT	N/A
N/A	Flare Slope LT (%)	N/A	N/A	Flare Slope RT (%)	N/A
N/A	Flare Traversable LT?	N/A	N/A	Flare Traversable RT?	N/A
N/A	Landing Length (in)	N/A	N/A	DWS Provided?	N/A
N/A	Landing Width (in)	N/A	N/A	DWS Contrast?	N/A
N/A	Landing Slope (%)	N/A	N/A	DWS Length (in)	N/A
N/A	Landing X Slope (%)	N/A	N/A	DWS Full Width?	N/A
N/A	Landing Curb? (Y/N)	N/A	N/A	DWS Offset (in)	N/A
N/A	Shared Landing?	N/A			
N/A	Gutter Ponding?	N/A	N/A	Gutter Slope (%)	N/A
N/A	Gutter Lip Ht (in)	N/A	N/A	Gutter X Slope (%)	N/A
N/A	Painted X Walk1?	No	N/A	Painted X Walk2?	No
	X Walk 1 Direction	To SE		X Walk 2 Direction	To NE
N/A	X Walk 1 Width (in)	N/A	N/A	X Walk 2 Width (in)	N/A
	X Walk 1 Slope (%)	0.7		X Walk 2 Slope (%)	0.2
	X Walk 1 X Slope (%)	1.0		X Walk 2 X Slope (%)	1.4

N/A	Ramp inside XWalk1?	N/A	N/A	Ramp inside XWalk2?	N/A
	Road Slope (%)	0.0	N/A	Clear Space?	N/A
	Road X Slope (%)	0.4	N/A	Clear Space to XWalk (in)	N/A
N/A	Any Obstructions?	N/A	N/A	Storm Grate/Utility Hazard?	N/A
	Obstruction Type			Storm Grate/Utility Type	
		N/A			N/A
			Yes	Surface Condition? (G/P)	Good

Possible Solutions:

**Remove & Replace Curb Ramp With Two New Directional Ramps or Equivalent.**

PROW/ADA:

**R304.5.1, R304.2.2**

Total Cost: \$ 3200.00
