Access Compliance Report

Public Rights-of-Way

(Curb Ramps)

Intersection ID: 8311	Main Street: BUTLER_RD	Cross Street: INTERURBAN_AV	Location:	W
ADA ID: F45E93D3F2B1	Ramp Type: Perp	Initial Pass/Fail: Fail	Overall Compliance: No	Severity Score: 10
Codes/Mitigation Info/Possible Solution		Field Measurements/Component Compliance

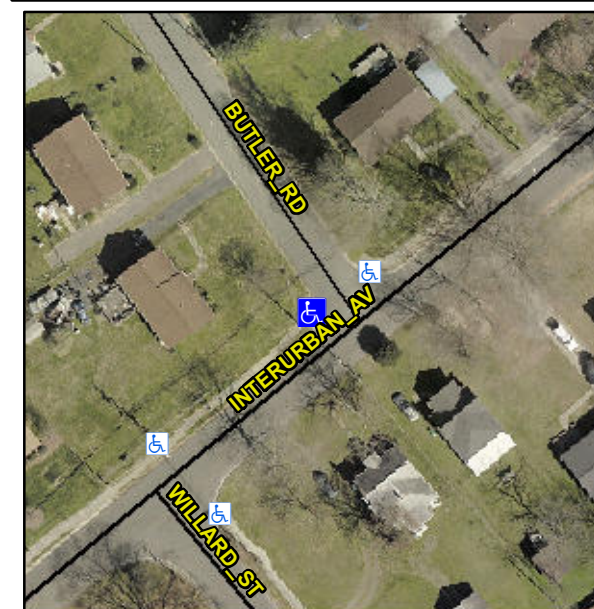
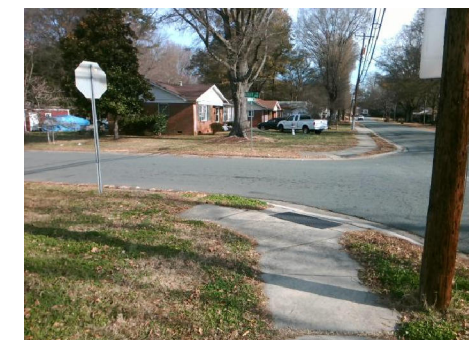
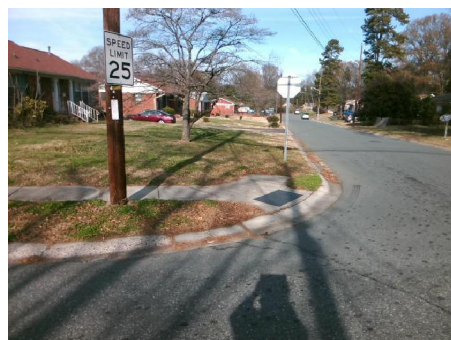
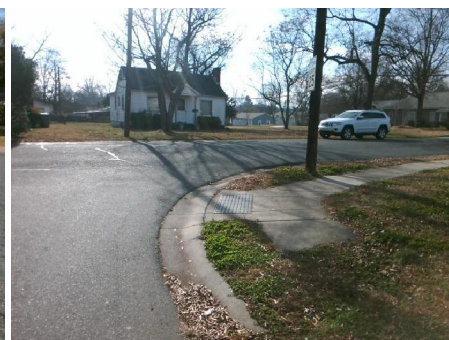
Not Found, R304.5.1, R304.5.3

Compliance	Description	Data	Compliance	Description	Data
N/A	Ramp Length (in)	24.0	Yes	Ramp Slope (%)	6.1
No	Ramp Width (in)	37.5	No	Ramp XSlope (%)	2.8
N/A	Flare Type LT	N/A	N/A	Flare Type RT	N/A
N/A	Flare Slope LT (%)	N/A	N/A	Flare Slope RT (%)	N/A
N/A	Flare Traversable LT?	N/A	N/A	Flare Traversable RT?	N/A
N/A	Landing Length (in)	N/A	N/A	DWS Provided?	N/A
N/A	Landing Width (in)	N/A	N/A	DWS Contrast?	N/A
N/A	Landing Slope (%)	N/A	N/A	DWS Length (in)	N/A
N/A	Landing X Slope (%)	N/A	N/A	DWS Full Width?	N/A
N/A	Landing Curb? (Y/N)	N/A	N/A	DWS Offset (in)	N/A
N/A	Shared Landing?	N/A			
N/A	Gutter Ponding?	N/A	N/A	Gutter Slope (%)	N/A
N/A	Gutter Lip Ht (in)	N/A	N/A	Gutter X Slope (%)	N/A
N/A	Painted X Walk1?	No	N/A	Painted X Walk2?	N/A
	X Walk 1 Direction	To NE		X Walk 2 Direction	N/A
N/A	X Walk 1 Width (in)	N/A	N/A	X Walk 2 Width (in)	N/A
	X Walk 1 Slope (%)	4.7		X Walk 2 Slope (%)	N/A
	X Walk 1 X Slope (%)	4.4		X Walk 2 X Slope (%)	N/A

N/A	Ramp inside XWalk1?	N/A	N/A	Ramp inside XWalk2?	N/A
	Road Slope (%)	N/A	N/A	Clear Space?	N/A
	Road X Slope (%)	N/A	N/A	Clear Space to XWalk (in)	N/A
N/A	Any Obstructions?	N/A	N/A	Storm Grate/Utility Hazard?	N/A
	Obstruction Type			Storm Grate/Utility Type	
		N/A			N/A
			Yes	Surface Condition? (G/P)	Good

Remove & Replace Entire Ramp.

Total Cost: \$ 1850.00
