# Access Compliance Report

## Public Rights-of-Way

### (Curb Ramps)

Intersection ID: 23967	Main Street: AILEEN_CR	Cross Street: CHINA_GROVE_CHURCH_RD	Location: NW
ADA ID: F463A142E9AC	Ramp Type: PerpDiag	Initial Pass/Fail: Fail	Overall Compliance: No
		Severity Score: 33.75

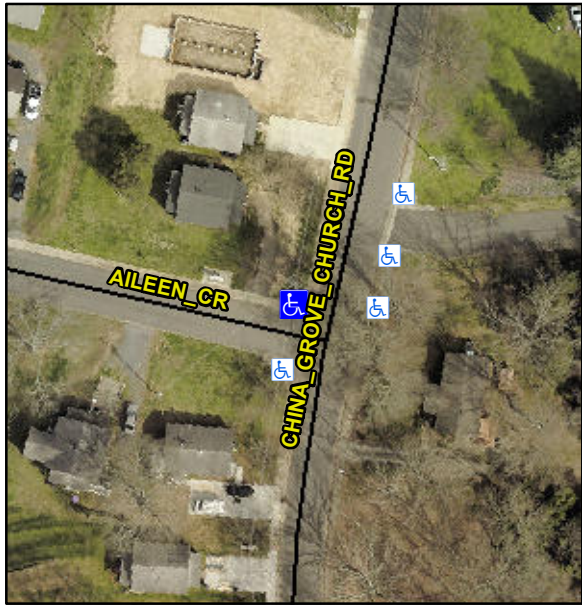
Possible Solutions:	Compliance	Description	Data	Compliance	Description	Data
	Remove & Replace Curb Ramp With Two New Directional Ramps or Equivalent.	N/A	Ramp Length (in)	48.0	No	Ramp Slope (%)	11.1
		No	Ramp Width (in)	43.0	No	Ramp XSlope (%)	5.1
		N/A	Flare Type LT	N/A	N/A	Flare Type RT	N/A
	N/A	Flare Slope LT (%)	N/A	N/A	Flare Slope RT (%)	N/A	
	N/A	Flare Traversable LT?	N/A	N/A	Flare Traversable RT?	N/A	
	N/A	Landing Length (in)	N/A	N/A	DWS Provided?	N/A	
	N/A	Landing Width (in)	N/A	N/A	DWS Contrast?	N/A	
	N/A	Landing Slope (%)	N/A	N/A	DWS Length (in)	N/A	
	N/A	Landing X Slope (%)	N/A	N/A	DWS Full Width?	N/A	
N/A	Landing Curb? (Y/N)	N/A	N/A	DWS Offset (in)	N/A		
Surveyor Notes:	N/A	N/A	Shared Landing?	N/A			
		N/A	Gutter Ponding?	N/A	N/A	Gutter Slope (%)	N/A
		N/A	Gutter Lip Ht (in)	N/A	N/A	Gutter X Slope (%)	N/A

PROW/ADA:	N/A	Painted X Walk1?	No	N/A	Painted X Walk2?	No
			X Walk 1 Direction	To SW		X Walk 2 Direction	To SE
		N/A	X Walk 1 Width (in)	N/A	N/A	X Walk 2 Width (in)	N/A
			X Walk 1 Slope (%)	0.2		X Walk 2 Slope (%)	2.8
			X Walk 1 X Slope (%)	3.0		X Walk 2 X Slope (%)	5.7
		N/A	Ramp inside XWalk1?	N/A	N/A	Ramp inside XWalk2?	N/A
			Road Slope (%)	4.8	N/A	Clear Space?	N/A
	Road X Slope (%)	1.3	N/A	Clear Space to XWalk (in)	N/A		
Total Cost:	\$ 3200.00	N/A	Any Obstructions?	N/A	N/A	Storm Grate/Utility Hazard?	N/A
			Obstruction Type			Storm Grate/Utility Type	
				N/A			N/A
				Yes	Surface Condition? (G/P)	Good
