Access Compliance Report Public Rights-of-Way (Curb Ramps)

Intersection ID: 22862Main Street: CAMILLA_DRCross Street: INNSBROOK_RDLocation:NADA ID: F46AEF03933ERamp Type: PerpDiagInitial Pass/Fail: FailOverall Compliance: NoSeverity Score: 37.5

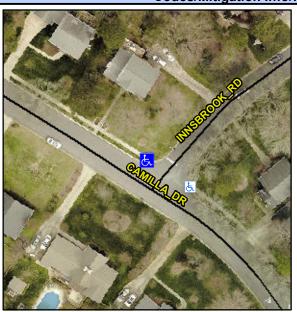
Not Found, R304.2.2, R304.5.3

Compliance Description Da		Data	Comp	liance	Description	Data
N/A	Ramp Length (in)	39.0	No	Ramp	Slope (%)	9.5
Yes	Ramp Width (in)	48.0	No	Ramp	XSlope (%)	7.9
N/A	Flare Type LT	N/A	N/A	Flare	Type RT	N/A
N/A	Flare Slope LT (%)	N/A	N/A	Flare	Slope RT (%)	N/A
N/A	Flare Traversable LT?	N/A	N/A	Flare	Traversable RT?	N/A
N/A	Landing Length (in)	N/A	N/A	DWS	Provided?	N/A
N/A	Landing Width (in)	N/A	N/A	DWS	Contrast?	N/A
N/A	Landing Slope (%)	N/A	N/A	DWS	Length (in)	N/A
N/A	Landing X Slope (%)	N/A	N/A	DWS	Full Width?	N/A
N/A	Landing Curb? (Y/N)	N/A	N/A	DWS	Offset (in)	N/A
N/A	Shared Landing?	N/A				
N/A	Gutter Ponding?	N/A	N/A	Gutte	er Slope (%)	N/A
N/A	Gutter Lip Ht (in)	N/A	N/A	Gutte	r X Slope (%)	N/A
N/A	Painted X Walk1?	No	N/A	Paint	ed X Walk2?	No
	X Walk 1 Direction	To SW		X Wa	lk 2 Direction	To SE
N/A	X Walk 1 Width (in)	N/A	N/A	X Wa	lk 2 Width (in)	N/A
	X Walk 1 Slope (%)	6.9		X Wa	lk 2 Slope (%)	2.3
	X Walk 1 X Slope (%)	4.2		X Wa	lk 2 X Slope (%)	5.9

N/A	Ramp inside XWalk1?	N/A	N/A	Ram	inside XWalk2?	N/A
	Road Slope (%)	7.2	N/A	Clear	Space?	N/A
	Road X Slope (%)	3.4	N/A	Clear	Space to XWalk (in)	N/A
N/A	Any Obstructions?	N/A	N/A	Storn	n Grate/Utility Hazard?	N/A
	Obstruction Type		l	Storn	n Grate/Utility Type	
		N/A				N/A
			Yes	Surfa	ce Condition? (G/P)	Good

Remove & Replace Curb Ramp With Two New Directional Ramps or Equivalent.
