# Access Compliance Report

## Public Rights-of-Way

### (Curb Ramps)

Intersection ID: 27755	Main Street: BALLANTYNE_CROSSING_AV	Cross Street: NOLEN_LN	Location: NE
ADA ID: F4721DF4B568	Ramp Type: BlendTrans1	Initial Pass/Fail: Fail	Overall Compliance: No
Severity Score: 10			
Codes/Mitigation Info/Possible Solution		Field Measurements/Component Compliance

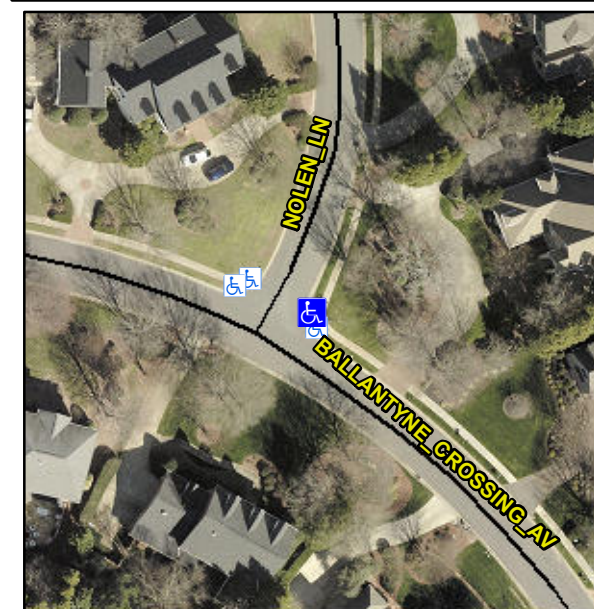
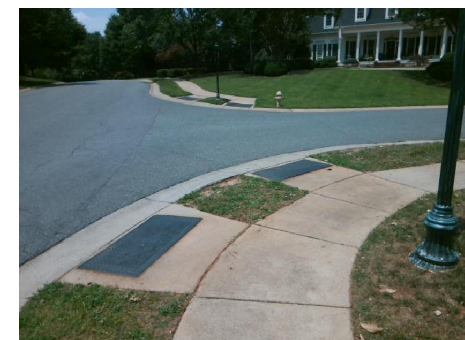
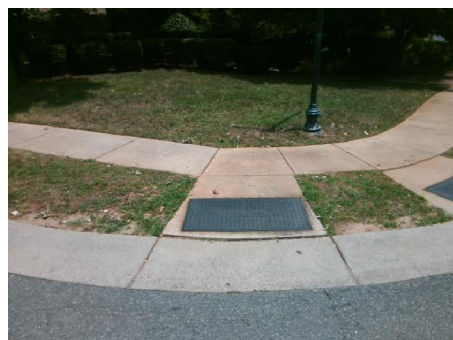
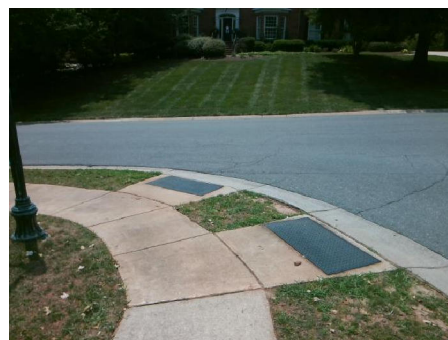
**GTR GAP 1.0**

**Not Found, R304.5.1, R304.5.3**

Compliance	Description	Data	Compliance	Description	Data
N/A	Ramp Length (in)	55.0	Yes	BlendTrans Slope (%)	2.2
No	Ramp Width (in)	46.5	No	BlendTrans XSlope (%)	2.9
N/A	Flare Type LT	N/A	N/A	Flare Type RT	N/A
N/A	Flare Slope LT (%)	N/A	N/A	Flare Slope RT (%)	N/A
N/A	Flare Traversable LT?	N/A	N/A	Flare Traversable RT?	N/A
N/A	Landing Length (in)	N/A	N/A	DWS Provided?	N/A
N/A	Landing Width (in)	N/A	N/A	DWS Contrast?	N/A
N/A	Landing Slope (%)	N/A	N/A	DWS Length (in)	N/A
N/A	Landing X Slope (%)	N/A	N/A	DWS Full Width?	N/A
N/A	Landing Curb? (Y/N)	N/A	N/A	DWS Offset (in)	N/A
N/A	Shared Landing?	N/A			
N/A	Gutter Ponding?	N/A	N/A	Gutter Slope (%)	N/A
N/A	Gutter Lip Ht (in)	N/A	N/A	Gutter X Slope (%)	N/A
N/A	Painted X Walk1?	No	N/A	Painted X Walk2?	N/A
	X Walk 1 Direction	To NW		X Walk 2 Direction	N/A
	X Walk 1 Width (in)	N/A		X Walk 2 Width (in)	N/A
	X Walk 1 Slope (%)	2.5		X Walk 2 Slope (%)	N/A
	X Walk 1 X Slope (%)	0.6		X Walk 2 X Slope (%)	N/A

N/A	Ramp inside XWalk1?	N/A	N/A	Ramp inside XWalk2?	N/A
	Road Slope (%)	0.6		Clear Space?	N/A
	Road X Slope (%)	2.5	N/A	Clear Space to XWalk (in)	N/A
N/A	Any Obstructions?	N/A	N/A	Storm Grate/Utility Hazard?	N/A
	Obstruction Type			Storm Grate/Utility Type	
		N/A			N/A
			Yes	Surface Condition? (G/P)	Good
			No	Curb Slope (%)	8.6

**Remove & Replace Curb Ramp With Two New Directional Ramps or Equivalent.**

Total Cost: \$ 3200.00
