## Access Compliance Report Public Rights-of-Way (Curb Ramps)

Intersection ID: 48851 Main Street: WEDDINGTON\_RD Cross Street: FINCHER\_FARM\_RD Location: SW

ADA ID: F47911BB0B7D Ramp Type: PerpDiag Initial Pass/Fail: Fail Overall Compliance: No Severity Score: 21.25

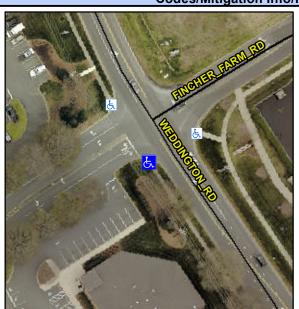
Not Found, R304.5.1, R304.2.2

| Field Measurements/Component Compliance | | | | | | |
|---|---|---|---|---|---|---|
| | N/A | Ramp Length (in) | 40.0 | No | Ramp Slope (%) | 9.5 |
| | No | Ramp Width (in) | 39.0 | Yes | Ramp XSlope (%) | 1.8 |

Remove & Replace Curb Ramp With Two New Directional Ramps or Equivalent.
