Access Compliance Report

Public Rights-of-Way

(Curb Ramps)

Intersection ID: N/A	Main Street: POTOMAC_RIVER_PY	Cross Street: NATIONAL_AV	Location: W
ADA ID: F47FEC50CBD8	Ramp Type: Perp	Initial Pass/Fail: Fail	Overall Compliance: No
		Severity Score: 12.5

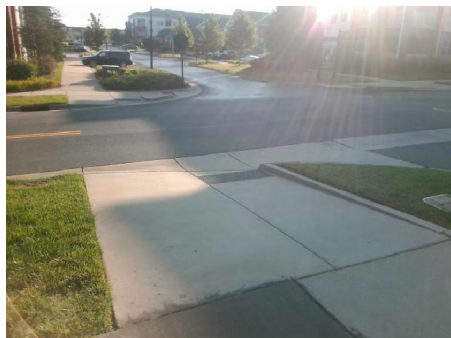
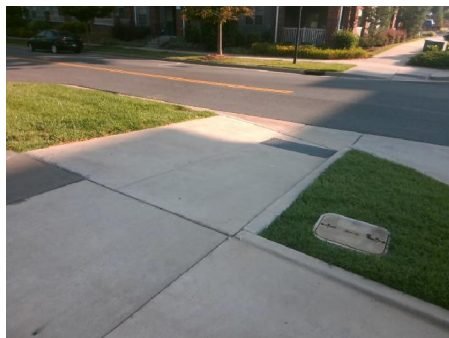
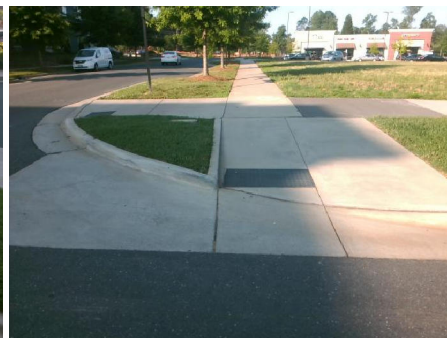
Not Found, R304.2.2

Compliance	Description	Data	Compliance	Description	Data
N/A	Ramp Length (in)	140.0	No	Ramp Slope (%)	10.8
Yes	Ramp Width (in)	55.0	Yes	Ramp XSlope (%)	0.8
N/A	Flare Type LT	N/A	N/A	Flare Type RT	N/A
N/A	Flare Slope LT (%)	N/A	N/A	Flare Slope RT (%)	N/A
N/A	Flare Traversable LT?	N/A	N/A	Flare Traversable RT?	N/A
N/A	Landing Length (in)	N/A	N/A	DWS Provided?	N/A
N/A	Landing Width (in)	N/A	N/A	DWS Contrast?	N/A
N/A	Landing Slope (%)	N/A	N/A	DWS Length (in)	N/A
N/A	Landing X Slope (%)	N/A	N/A	DWS Full Width?	N/A
N/A	Landing Curb? (Y/N)	N/A	N/A	DWS Offset (in)	N/A
N/A	Shared Landing?	N/A			
N/A	Gutter Ponding?	N/A	N/A	Gutter Slope (%)	N/A
N/A	Gutter Lip Ht (in)	N/A	N/A	Gutter X Slope (%)	N/A
N/A	Painted X Walk1?	No	N/A	Painted X Walk2?	N/A
	X Walk 1 Direction	To NE		X Walk 2 Direction	N/A
N/A	X Walk 1 Width (in)	N/A	N/A	X Walk 2 Width (in)	N/A
	X Walk 1 Slope (%)	4.6		X Walk 2 Slope (%)	N/A
	X Walk 1 X Slope (%)	2.9		X Walk 2 X Slope (%)	N/A

N/A	Ramp inside XWalk1?	N/A	N/A	Ramp inside XWalk2?	N/A
	Road Slope (%)	N/A	N/A	Clear Space?	N/A
	Road X Slope (%)	N/A	N/A	Clear Space to XWalk (in)	N/A
N/A	Any Obstructions?	N/A	N/A	Storm Grate/Utility Hazard?	N/A
	Obstruction Type			Storm Grate/Utility Type	
		N/A			N/A
			Yes	Surface Condition? (G/P)	Good

Remove & Replace Entire Ramp.
