## Access Compliance Report Public Rights-of-Way (Curb Ramps)

Intersection ID: 46759	Section ID: 46759 Main Street: PONTCHATRAIN_AV			Cross Street: CUMBERLAND_COVE_DR				Location:	SW	
ADA ID: F48F1535EA8F	D: F48F1535EA8F Ramp Type: Perp			Initial Pass/Fail: Fail Overall Compliance: No				o Severity Score:	25	
Codes/Mitigation Info/Possible Solution				Field Measurements/Component Compliance						
	i the hi	Possible Solutions:		Compliance Description			Data Compliance Description			
	the state of the	Remove & Replace Entire Ram	0.	N/A	Ramp Length (in)	47.0	Yes	Ramp Slope (%)	5.4

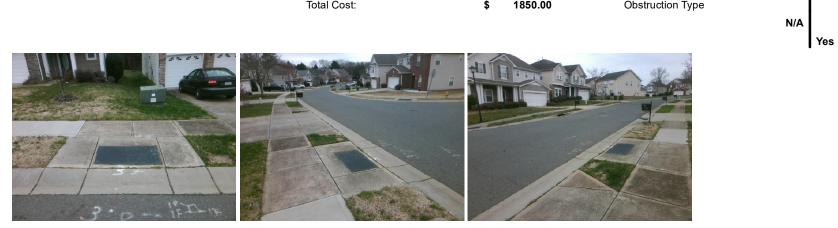
-	Yes	Ramp Width (in)	52.0	No	Ramp XSlope (%)	9.4	
	ONE DU			N/A	Flare Type LT	N/A	N/A	Flare Type RT	N/A	
	MD			N/A	Flare Slope LT (%)	N/A	N/A	Flare Slope RT (%)	N/A	
	CEERL AND	6		N/A	Flare Traversable LT?	N/A	N/A	Flare Traversable RT?	N/A	
See See				N/A	Landing Length (in)	N/A	N/A	DWS Provided?	N/A	
	i A A	Surveyor Notes:		N/A	Landing Width (in)	N/A	N/A	DWS Contrast?	N/A	
	1 1 1	N/A		N/A	Landing Slope (%)	N/A	N/A	DWS Length (in)	N/A	
				N/A	Landing X Slope (%)	N/A	N/A	DWS Full Width?	N/A	
	Hz C			N/A	Landing Curb? (Y/N)	N/A	N/A	DWS Offset (in)	N/A	
The second second				N/A	Shared Landing?	N/A				
	1 State	PROW/ADA:		N/A	Gutter Ponding?	N/A	N/A	Gutter Slope (%)	N/A	
		Not Found, R304.5.3		N/A	Gutter Lip Ht (in)	N/A	N/A	Gutter X Slope (%)	N/A	
	2111			N/A	Painted X Walk1?	No	N/A	Painted X Walk2?	N/A	
CAR AND					X Walk 1 Direction	To NE		X Walk 2 Direction	N/A	
				N/A	X Walk 1 Width (in)	N/A	N/A	X Walk 2 Width (in)	N/A
