# Access Compliance Report

## Public Rights-of-Way

### (Curb Ramps)

Intersection ID: 16419	Main Street: LANTANA_AV	Cross Street: N_SHARON_AMITY_RD	Location: NW
ADA ID: F49ADEF47FFF	Ramp Type: PerpDiag	Initial Pass/Fail: Fail	Overall Compliance: No
Severity Score: 10			
Codes/Mitigation Info/Possible Solution		Field Measurements/Component Compliance

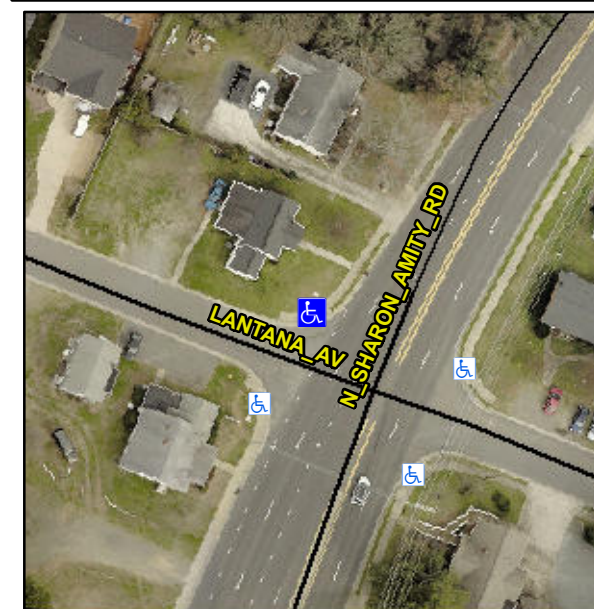
**Not Found, R304.5.1, R304.5.3**

Compliance	Description	Data	Compliance	Description	Data
N/A	Ramp Length (in)	73.0	Yes	Ramp Slope (%)	5.2
No	Ramp Width (in)	41.0	No	Ramp XSlope (%)	2.3
N/A	Flare Type LT	N/A	N/A	Flare Type RT	N/A
N/A	Flare Slope LT (%)	N/A	N/A	Flare Slope RT (%)	N/A
N/A	Flare Traversable LT?	N/A	N/A	Flare Traversable RT?	N/A
N/A	Landing Length (in)	N/A	N/A	DWS Provided?	N/A
N/A	Landing Width (in)	N/A	N/A	DWS Contrast?	N/A
N/A	Landing Slope (%)	N/A	N/A	DWS Length (in)	N/A
N/A	Landing X Slope (%)	N/A	N/A	DWS Full Width?	N/A
N/A	Landing Curb? (Y/N)	N/A	N/A	DWS Offset (in)	N/A
N/A	Shared Landing?	N/A			
N/A	Gutter Ponding?	N/A	N/A	Gutter Slope (%)	N/A
N/A	Gutter Lip Ht (in)	N/A	N/A	Gutter X Slope (%)	N/A
N/A	Painted X Walk1?	No	N/A	Painted X Walk2?	No
	X Walk 1 Direction	To SW		X Walk 2 Direction	To SE
N/A	X Walk 1 Width (in)	N/A	N/A	X Walk 2 Width (in)	N/A
	X Walk 1 Slope (%)	2.8		X Walk 2 Slope (%)	5.3
	X Walk 1 X Slope (%)	4.8		X Walk 2 X Slope (%)	0.3

N/A	Ramp inside XWalk1?	N/A	N/A	Ramp inside XWalk2?	N/A
	Road Slope (%)	1.9	N/A	Clear Space?	N/A
	Road X Slope (%)	5.1	N/A	Clear Space to XWalk (in)	N/A
N/A	Any Obstructions?	N/A	N/A	Storm Grate/Utility Hazard?	N/A
	Obstruction Type			Storm Grate/Utility Type	
		N/A			N/A
			Yes	Surface Condition? (G/P)	Good

**Remove & Replace Curb Ramp With Two New Directional Ramps or Equivalent.**

Total Cost: \$ 3200.00

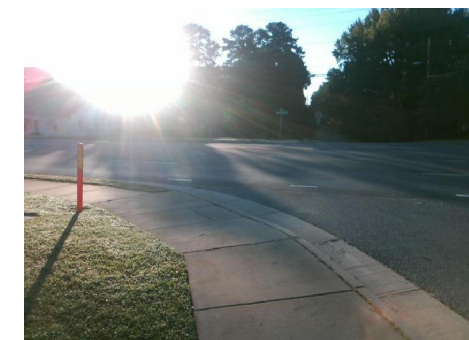
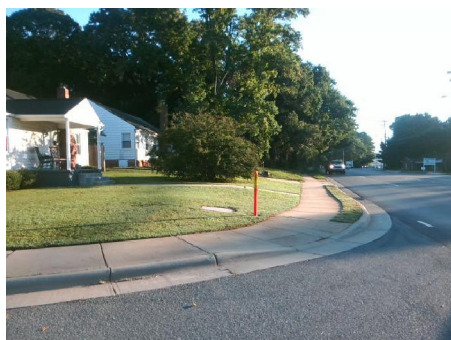
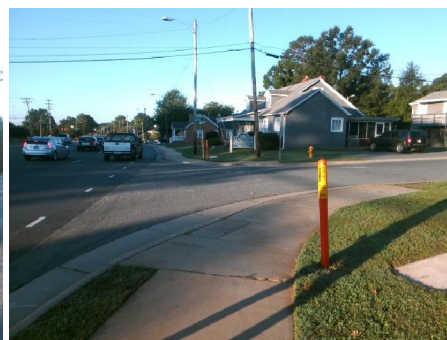
Street 1 Name LANTANA AV  
 Stop Condition-Street 2 StopSign  
 Street 2 Name N SHARON AMITY RD  
 Stop Condition-Street 1 None
