Access Compliance Report

Public Rights-of-Way (Curb Ramps)

Intersection ID: 5763	Main Street: RICHFIELD_LN	Cross Street: STATESVILLE_RD	Location: SW
ADA ID: F49F525ABDC3	Ramp Type: Directional1	Initial Pass/Fail: Fail	Overall Compliance: No
Severity Score: 1.25			
Codes/Mitigation Info/Possible Solution		Field Measurements/Component Compliance

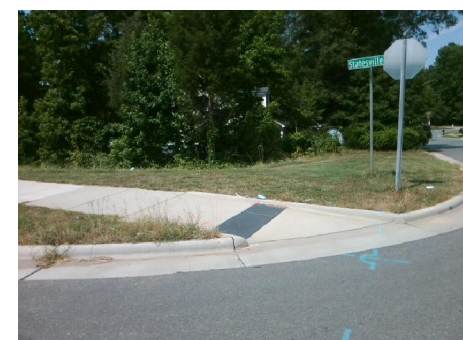
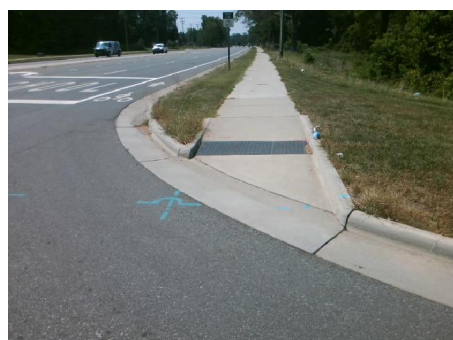
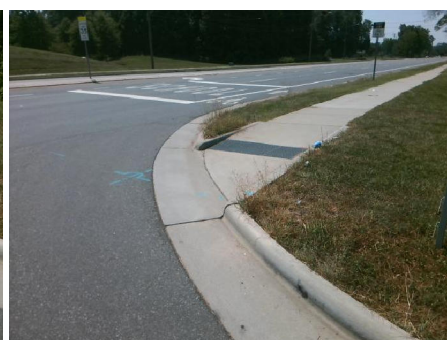
Compliance	Description	Data	Compliance	Description	Data
N/A	Ramp Length (in)	86.0	N/A	Grade Break?	N/A
Yes	Ramp Width (in)	69.0	N/A	Grade Break Slope (%)	0.0
Yes	Ramp Slope (%)	7.5	N/A	Grade Break XSlope (%)	0.0
No	Ramp XSlope (%)	4.4			
N/A	Flare Type LT	N/A	N/A	Flare Type RT	N/A
N/A	Flare Slope LT (%)	N/A	N/A	Flare Slope RT (%)	0.0
N/A	Flare Traversable LT?	N/A	N/A	Flare Traversable RT?	N/A
N/A	Landing Length (in)	0.0	N/A	DWS Provided?	N/A
N/A	Landing Width (in)	0.0	N/A	DWS Contrast?	N/A
N/A	Landing Slope (%)	0.0	N/A	DWS Length (in)	N/A
N/A	Landing X Slope (%)	0.0	N/A	DWS Full Width?	N/A
N/A	Landing Curb? (Y/N)	N/A	N/A	DWS Offset LT (in)	N/A
N/A	Shared Landing?	N/A	N/A	DWS Offset RT (in)	N/A
N/A	Gutter Ponding?	0.0	N/A	Gutter Slope (%)	N/A
N/A	Gutter Lip Ht (in)	0.0	N/A	Gutter X Slope (%)	N/A
N/A	Painted X Walk1?	No		Road Slope (%)	0.1
	X Walk 1 Direction	To N		Road X Slope (%)	2.1
	X Walk 1 Width (in)	N/A		Clear Space?	N/A

X Walk 1 Slope (%)	0.1	N/A	Clear Space to XWalk (in)	N/A
	X Walk 1 X Slope (%)	2.1	N/A	Storm Grate/Utility Hazard?	N/A
N/A	Ramp inside XWalk1?	N/A		Storm Grate/Utility Type	
N/A	Any Obstructions?	N/A			N/A
	Obstruction Type		Yes	Surface Condition? (G/P)	Good
			N/A	Curb Slope (%)	N/A

Possible Solutions:

Remove & Replace Entire Ramp.

R304.5.3
