Access Compliance Report

Public Rights-of-Way

(Curb Ramps)

Intersection ID: 42761	Main Street: ERWIN_RIDGE_AV	Cross Street: OCONEE_LN	Location: W
ADA ID: F4AB2EB4226F	Ramp Type: PerpDiag	Initial Pass/Fail: Fail	Overall Compliance: No
Severity Score: 46.25			
Codes/Mitigation Info/Possible Solution		Field Measurements/Component Compliance

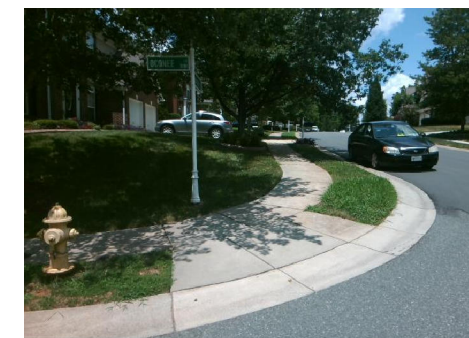
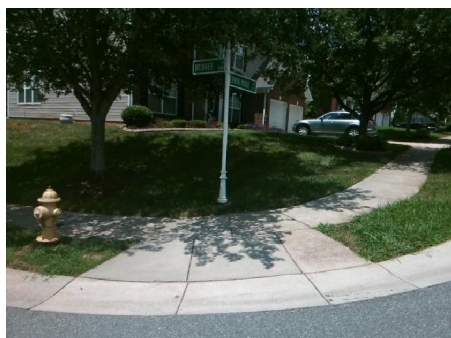
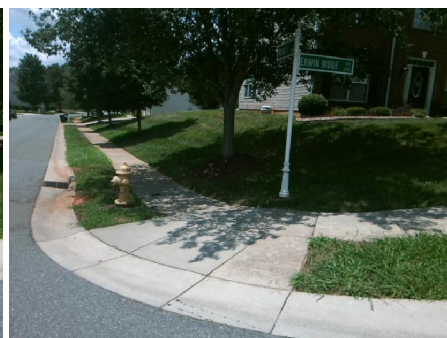
Compliance	Description	Data	Compliance	Description	Data
N/A	Ramp Length (in)	47.0	No	Ramp Slope (%)	8.8
No	Ramp Width (in)	44.5	No	Ramp XSlope (%)	10.2
N/A	Flare Type LT	N/A	N/A	Flare Type RT	N/A
N/A	Flare Slope LT (%)	N/A	N/A	Flare Slope RT (%)	N/A
N/A	Flare Traversable LT?	N/A	N/A	Flare Traversable RT?	N/A
N/A	Landing Length (in)	N/A	N/A	DWS Provided?	N/A
N/A	Landing Width (in)	N/A	N/A	DWS Contrast?	N/A
N/A	Landing Slope (%)	N/A	N/A	DWS Length (in)	N/A
N/A	Landing X Slope (%)	N/A	N/A	DWS Full Width?	N/A
N/A	Landing Curb? (Y/N)	N/A	N/A	DWS Offset (in)	N/A
N/A	Shared Landing?	N/A			
N/A	Gutter Ponding?	N/A	N/A	Gutter Slope (%)	N/A
N/A	Gutter Lip Ht (in)	N/A	N/A	Gutter X Slope (%)	N/A
N/A	Painted X Walk1?	No	N/A	Painted X Walk2?	No
	X Walk 1 Direction	To S		X Walk 2 Direction	To E
N/A	X Walk 1 Width (in)	N/A	N/A	X Walk 2 Width (in)	N/A
	X Walk 1 Slope (%)	0.3		X Walk 2 Slope (%)	7.6
	X Walk 1 X Slope (%)	8.8		X Walk 2 X Slope (%)	6.1

N/A	Ramp inside XWalk1?	N/A	N/A	Ramp inside XWalk2?	N/A
	Road Slope (%)	8.0	N/A	Clear Space?	N/A
	Road X Slope (%)	0.4	N/A	Clear Space to XWalk (in)	N/A
N/A	Any Obstructions?	N/A	N/A	Storm Grate/Utility Hazard?	N/A
	Obstruction Type			Storm Grate/Utility Type	
		N/A			N/A
			Yes	Surface Condition? (G/P)	Good

Remove & Replace Curb Ramp With Two New Directional Ramps or Equivalent.
