Access Compliance Report Public Rights-of-Way (Curb Ramps)

Intersection ID: 15173 Main Street: ALBEMARLE RD **Cross Street: EXECUTIVE CENTER DR** Location: SE ADA ID: F4B1154E1853 Ramp Type: PerpDiag Initial Pass/Fail: Fail **Overall Compliance: No** Severity Score: 13.75

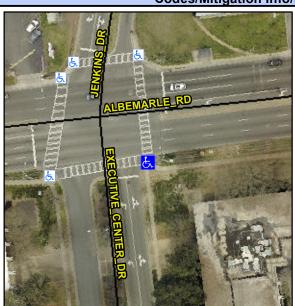
Compliance Description Data Compliance Description Data No Ramp Slope (%) N/A Ramp Length (in) 60.0 9.4 No Ramp XSlope (%) Yes Ramp Width (in) 60.0 2.1 N/A N/A Flare Type LT N/A Flare Type RT N/A N/A Flare Slope LT (%) N/A N/A Flare Slope RT (%) N/A N/A Flare Traversable LT? N/A N/A Flare Traversable RT? N/A N/A Landing Length (in) N/A N/A **DWS Provided?** N/A N/A Landing Width (in) N/A N/A **DWS Contrast?** N/A N/A N/A N/A Landing Slope (%) DWS Length (in) N/A N/A Landing X Slope (%) N/A N/A DWS Full Width? N/A N/A Landing Curb? (Y/N) N/A N/A DWS Offset (in) N/A N/A N/A Shared Landing? N/A **Gutter Ponding?** N/A N/A Gutter Slope (%) N/A N/A Gutter Lip Ht (in) N/A N/A Gutter X Slope (%) N/A N/A Painted X Walk1? Yes N/A Painted X Walk2? Yes X Walk 1 Direction To N X Walk 2 Direction To W N/A 112.0 X Walk 2 Width (in) 112.0 X Walk 1 Width (in) X Walk 1 Slope (%) 2.1 X Walk 2 Slope (%) 2.1 X Walk 1 X Slope (%) 0.6 X Walk 2 X Slope (%) 1.8 N/A N/A Ramp inside XWalk2? Ramp inside XWalk1? Yes Yes Road Slope (%) 1.0 N/A Clear Space? N/A N/A Road X Slope (%) 2.4 Clear Space to XWalk (in) N/A N/A N/A N/A Any Obstructions? Storm Grate/Utility Hazard? N/A **Obstruction Type** Storm Grate/Utility Type N/A N/A

Possible Solutions: Remove & Replace Curb Ramp With Two New Directional Ramps or Equivalent. Surveyor Notes: N/A PROW/ADA: Not Found, R304.2.2, R304.5.3
