# Access Compliance Report

## Public Rights-of-Way (Curb Ramps)

Intersection ID: 10033279	Main Street: OAKDALE_RD	Cross Street: N/A	Location: W
ADA ID: F4B36824F286	Ramp Type: Perp	Initial Pass/Fail: Fail	Overall Compliance: No
		Severity Score: 25

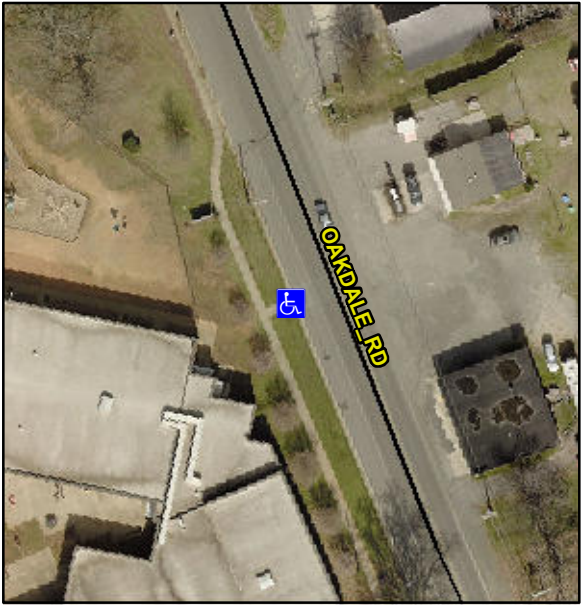
Possible Solutions:		<b>Compliance</b>	<b>Description</b>	<b>Data</b>
	<b>Remove &amp; Replace Entire Ramp.</b>		<b>No</b>	Ramp Length (in)	<b>161.0</b>
			<b>Yes</b>	Ramp Width (in)	<b>61.0</b>
			<b>N/A</b>	Flare Type LT	<b>N/A</b>
			<b>N/A</b>	Flare Slope LT (%)	<b>N/A</b>
			<b>N/A</b>	Flare Traversable LT?	<b>N/A</b>
			<b>N/A</b>	Landing Length (in)	<b>N/A</b>
			<b>N/A</b>	Landing Width (in)	<b>N/A</b>
			<b>N/A</b>	Landing Slope (%)	<b>N/A</b>
			<b>N/A</b>	Landing X Slope (%)	<b>N/A</b>
<p>Surveyor Notes:</p> <p><b>N/A</b></p> <p>PROW/ADA:</p> <p><b>R304.2.2</b></p>			<b>N/A</b>	Flare Type RT	<b>N/A</b>
			<b>N/A</b>	Flare Slope RT (%)	<b>N/A</b>
			<b>N/A</b>	Flare Traversable RT?	<b>N/A</b>
			<b>N/A</b>	DWS Provided?	<b>N/A</b>
			<b>N/A</b>	DWS Contrast?	<b>N/A</b>
			<b>N/A</b>	DWS Length (in)	<b>N/A</b>

<b>N/A</b>	DWS Full Width?	<b>N/A</b>
			<b>N/A</b>	DWS Offset (in)	<b>N/A</b>
			<b>N/A</b>	Shared Landing?	<b>N/A</b>
			<b>N/A</b>	Gutter Ponding?	<b>N/A</b>
			<b>N/A</b>	Gutter Lip Ht (in)	<b>N/A</b>
			<b>N/A</b>	Painted X Walk1?	<b>Yes</b>
				X Walk 1 Direction	<b>To E</b>
			<b>N/A</b>	X Walk 1 Width (in)	<b>125.0</b>
				X Walk 1 Slope (%)	<b>0.7</b>
				X Walk 1 X Slope (%)	<b>1.8</b>
			<b>N/A</b>	Ramp inside XWalk1?	<b>Yes</b>
			<b>N/A</b>	Road Slope (%)	<b>N/A</b>
			<b>N/A</b>	Road X Slope (%)	<b>N/A</b>
			<b>N/A</b>	Any Obstructions?	<b>N/A</b>
Total Cost:		<b>\$ 1850.00</b>		Obstruction Type	
			<b>N/A</b>		<b>N/A</b>
			<b>Yes</b>	Surface Condition? (G/P)	<b>Good</b>
