Access Compliance Report

Public Rights-of-Way

(Curb Ramps)

Intersection ID: 51353	Main Street: MCCULLOUGH_DR	Cross Street: BRENTMOOR_DR	Location: SW
ADA ID: F4BB35A81E23	Ramp Type: PerpDiag	Initial Pass/Fail: Fail	Overall Compliance: No
Severity Score: 22.5			
Codes/Mitigation Info/Possible Solution		Field Measurements/Component Compliance

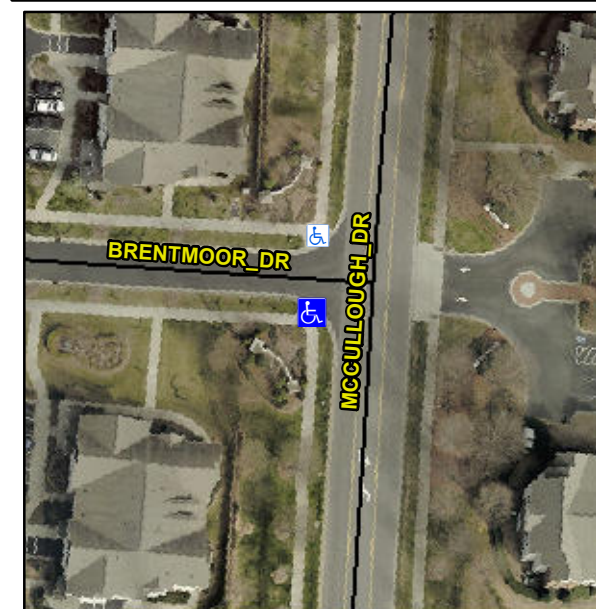
Not Found, R304.5.1, R304.2.2, R304.5.3

Compliance	Description	Data	Compliance	Description	Data
N/A	Ramp Length (in)	59.0	No	Ramp Slope (%)	9.6
No	Ramp Width (in)	47.0	No	Ramp XSlope (%)	2.7
N/A	Flare Type LT	N/A	N/A	Flare Type RT	N/A
N/A	Flare Slope LT (%)	N/A	N/A	Flare Slope RT (%)	N/A
N/A	Flare Traversable LT?	N/A	N/A	Flare Traversable RT?	N/A
N/A	Landing Length (in)	N/A	N/A	DWS Provided?	N/A
N/A	Landing Width (in)	N/A	N/A	DWS Contrast?	N/A
N/A	Landing Slope (%)	N/A	N/A	DWS Length (in)	N/A
N/A	Landing X Slope (%)	N/A	N/A	DWS Full Width?	N/A
N/A	Landing Curb? (Y/N)	N/A	N/A	DWS Offset (in)	N/A
N/A	Shared Landing?	N/A			
N/A	Gutter Ponding?	N/A	N/A	Gutter Slope (%)	N/A
N/A	Gutter Lip Ht (in)	N/A	N/A	Gutter X Slope (%)	N/A
N/A	Painted X Walk1?	No	N/A	Painted X Walk2?	No
	X Walk 1 Direction	To E		X Walk 2 Direction	To N
N/A	X Walk 1 Width (in)	N/A	N/A	X Walk 2 Width (in)	N/A
	X Walk 1 Slope (%)	5.8		X Walk 2 Slope (%)	0.4
	X Walk 1 X Slope (%)	0.7		X Walk 2 X Slope (%)	3.8

N/A	Ramp inside XWalk1?	N/A	N/A	Ramp inside XWalk2?	N/A
	Road Slope (%)	3.2	N/A	Clear Space?	N/A
	Road X Slope (%)	4.0	N/A	Clear Space to XWalk (in)	N/A
N/A	Any Obstructions?	N/A	N/A	Storm Grate/Utility Hazard?	N/A
	Obstruction Type			Storm Grate/Utility Type	
		N/A			N/A
			Yes	Surface Condition? (G/P)	Good

Remove & Replace Curb Ramp With Two New Directional Ramps or Equivalent.
