Access Compliance Report

Public Rights-of-Way

(Curb Ramps)

Intersection ID: 47610	Main Street: BATHURST_DR	Cross Street: MINTWORTH_AV	Location: SW
ADA ID: F4BC768C3096	Ramp Type: Perp	Initial Pass/Fail: Fail	Overall Compliance: No
Severity Score: 8.75			
Codes/Mitigation Info/Possible Solution		Field Measurements/Component Compliance

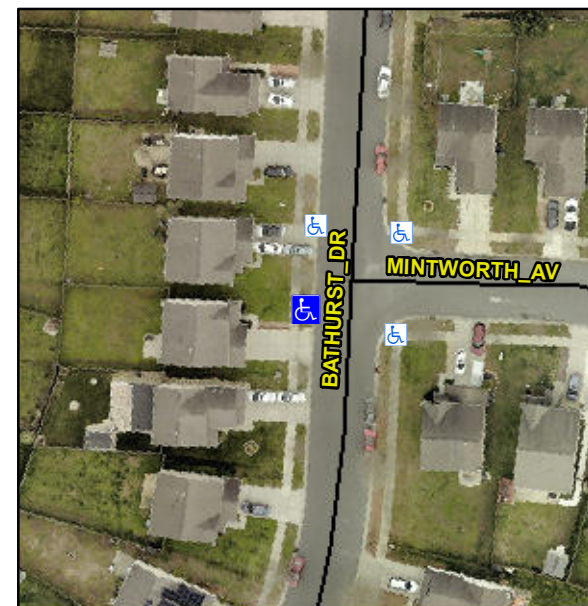
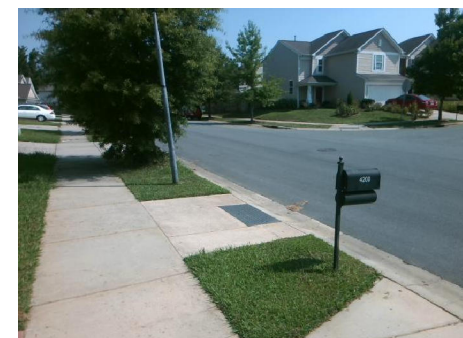
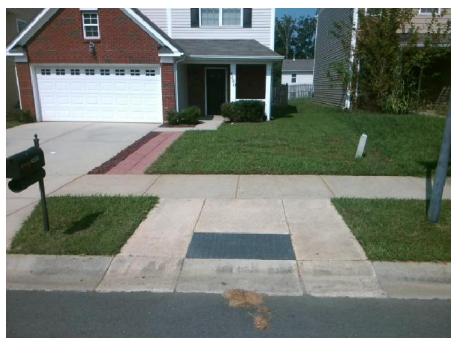
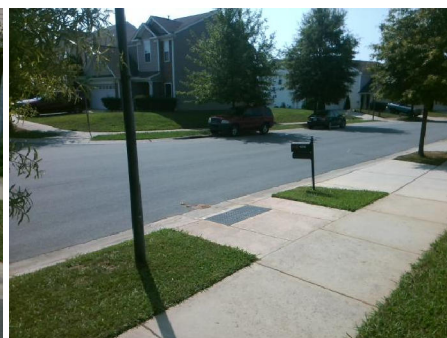
Not Found, R304.5.1

Compliance	Description	Data	Compliance	Description	Data
N/A	Ramp Length (in)	72.0	Yes	Ramp Slope (%)	7.0
No	Ramp Width (in)	46.5	Yes	Ramp XSlope (%)	0.6
N/A	Flare Type LT	N/A	N/A	Flare Type RT	N/A
N/A	Flare Slope LT (%)	N/A	N/A	Flare Slope RT (%)	N/A
N/A	Flare Traversable LT?	N/A	N/A	Flare Traversable RT?	N/A
N/A	Landing Length (in)	N/A	N/A	DWS Provided?	N/A
N/A	Landing Width (in)	N/A	N/A	DWS Contrast?	N/A
N/A	Landing Slope (%)	N/A	N/A	DWS Length (in)	N/A
N/A	Landing X Slope (%)	N/A	N/A	DWS Full Width?	N/A
N/A	Landing Curb? (Y/N)	N/A	N/A	DWS Offset (in)	N/A
N/A	Shared Landing?	N/A			
N/A	Gutter Ponding?	N/A	N/A	Gutter Slope (%)	N/A
N/A	Gutter Lip Ht (in)	N/A	N/A	Gutter X Slope (%)	N/A
N/A	Painted X Walk1?	No	N/A	Painted X Walk2?	N/A
	X Walk 1 Direction	To SE		X Walk 2 Direction	N/A
N/A	X Walk 1 Width (in)	N/A	N/A	X Walk 2 Width (in)	N/A
	X Walk 1 Slope (%)	3.7		X Walk 2 Slope (%)	N/A
	X Walk 1 X Slope (%)	0.2		X Walk 2 X Slope (%)	N/A

N/A	Ramp inside XWalk1?	N/A	N/A	Ramp inside XWalk2?	N/A
	Road Slope (%)	N/A	N/A	Clear Space?	N/A
	Road X Slope (%)	N/A	N/A	Clear Space to XWalk (in)	N/A
N/A	Any Obstructions?	N/A	N/A	Storm Grate/Utility Hazard?	N/A
	Obstruction Type			Storm Grate/Utility Type	
		N/A			N/A
			Yes	Surface Condition? (G/P)	Good

Possible Solutions:

Remove & Replace Entire Ramp.

Total Cost: \$ **1850.00**
